RAMM ROAD CONDITION RATING & ROUGHNESS

ROAD ASSESSMENT
AND MAINTENANCE
MANAGEMENT SYSTEM

PFM 6

RAMM - ROAD CONDITION RATING AND ROUGHNESS MANUAL

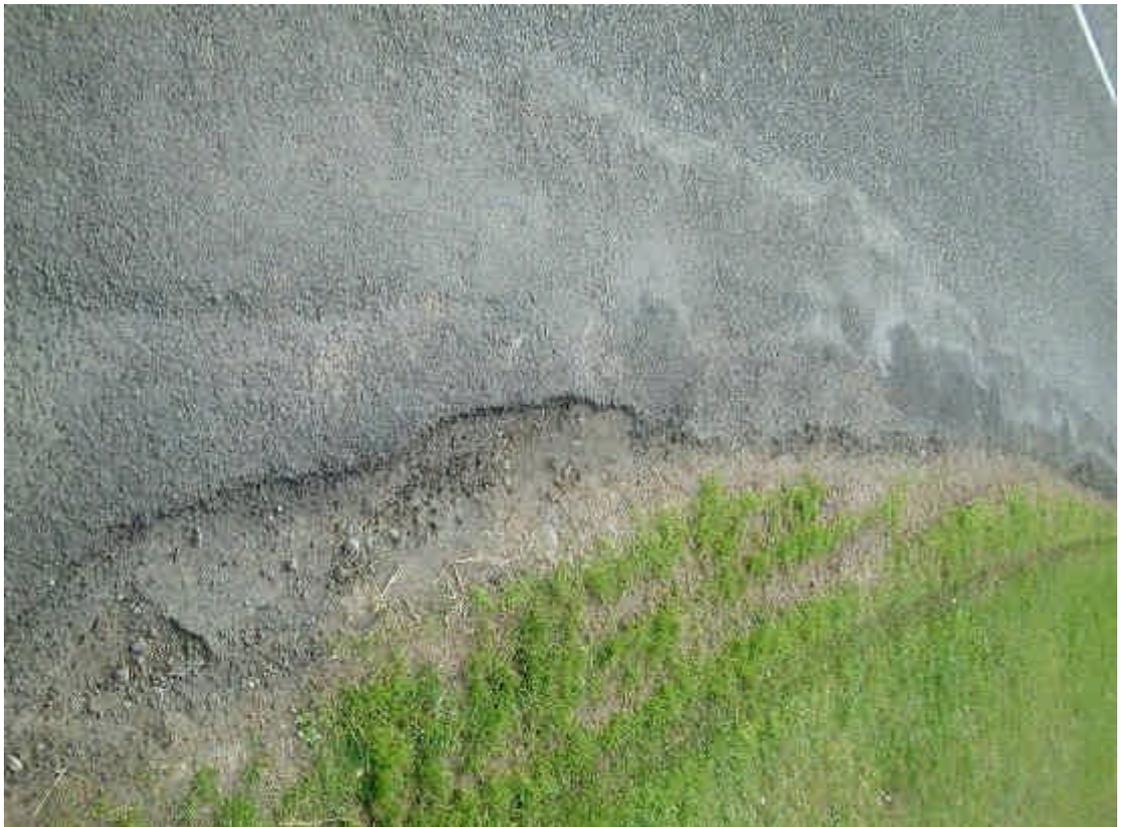
Shoulder is ineffective due to the wheel rut along the edge of the carriageway

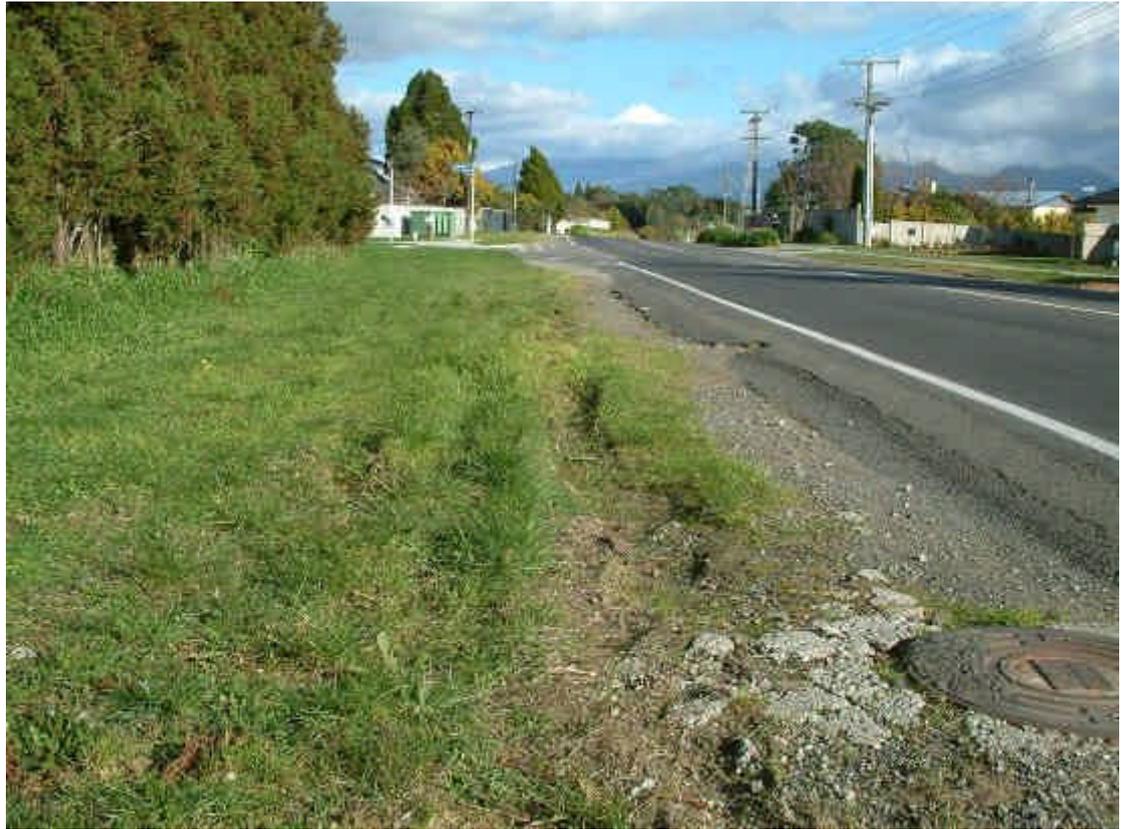
Ineffective shoulder due to deep tyre tracks.

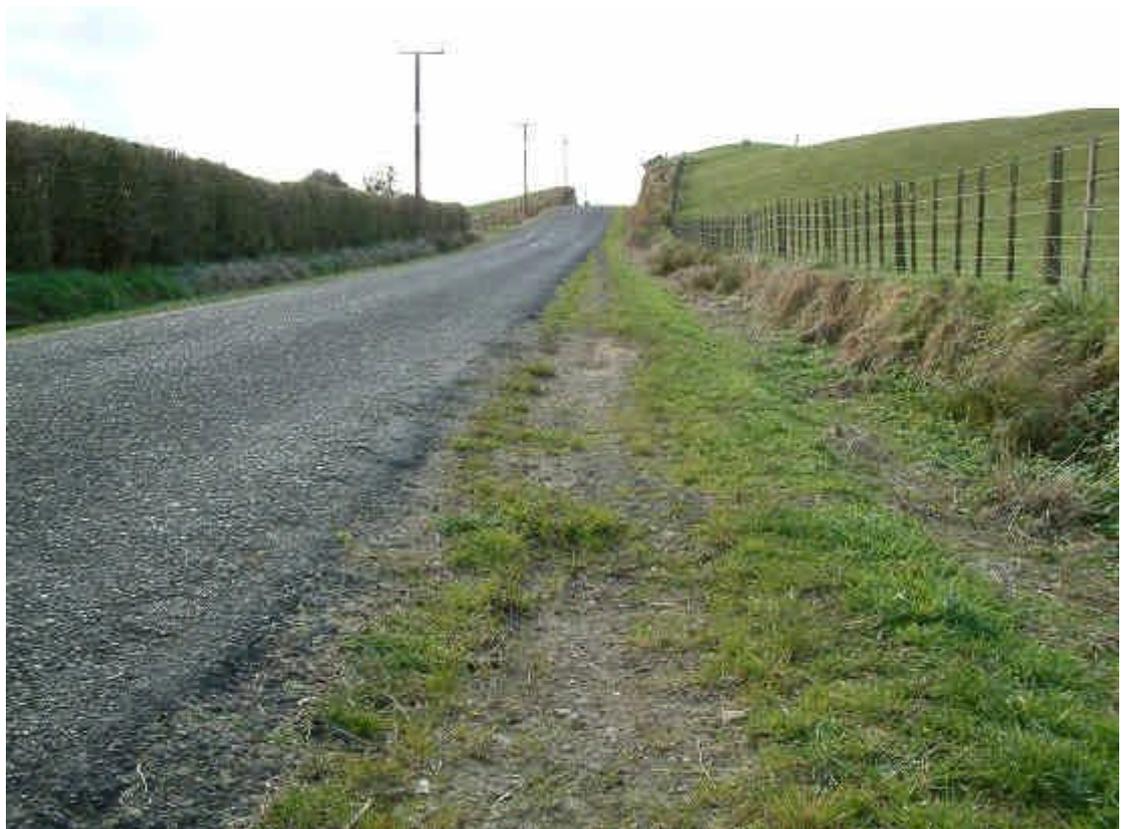
Ineffective shoulder due to the high area between the carriageway and the ESWC

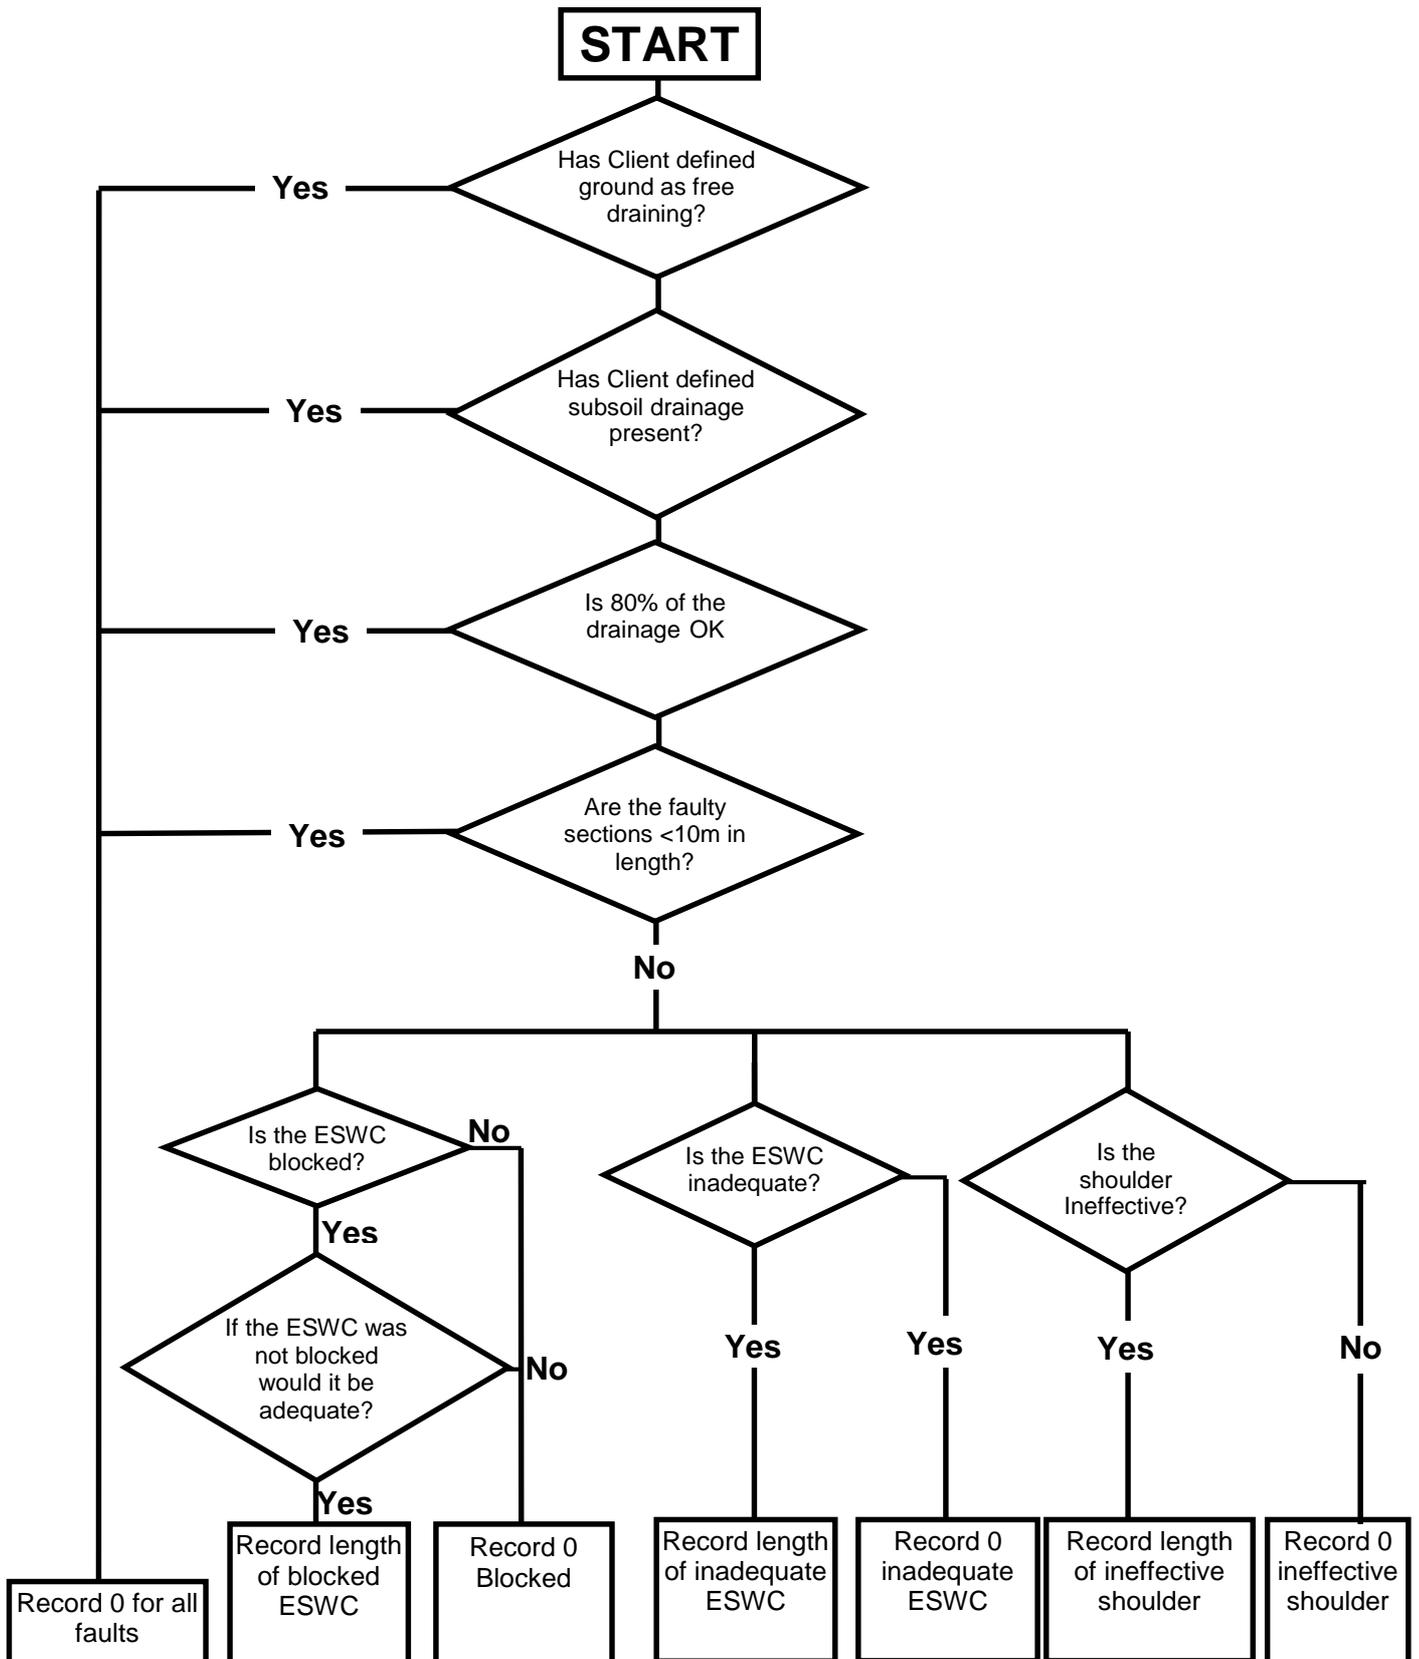
2.6 ESWC RATING FLOW DIAGRAM

The rater makes an initial assessment as to whether greater than 20% of the treatment length ESWC is inadequate due to ineffective shoulder or inadequate channel. If less than 20% of the section fails then zero is entered in the *inadequate* column. If greater than 20% fails as above, but the failed areas are less than 10m in length, then zero is entered as inadequate

If greater than 20% of the length fails, and this is made up of areas greater than 10m in length then the length failed is recorded.

This process may be modified at the client's discretion

The flow chart overleaf illustrates the logic flow for this method.

- 1 Indicates low severity of faults as typified by ESWCs that comply with the conditions in the flow chart above.
I.e. 80% of the ESWCs in the treatment length show no faults and faulty areas are less than 10m long

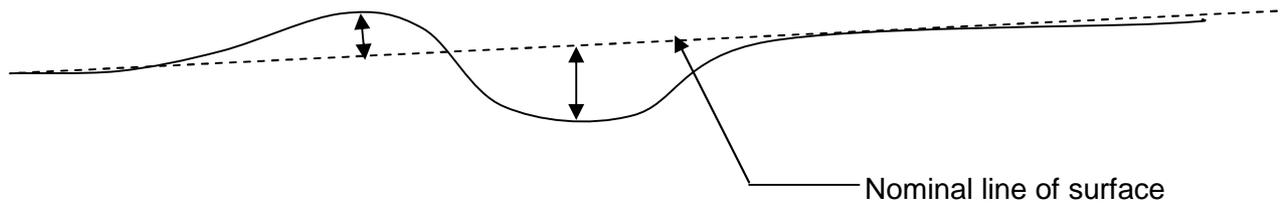
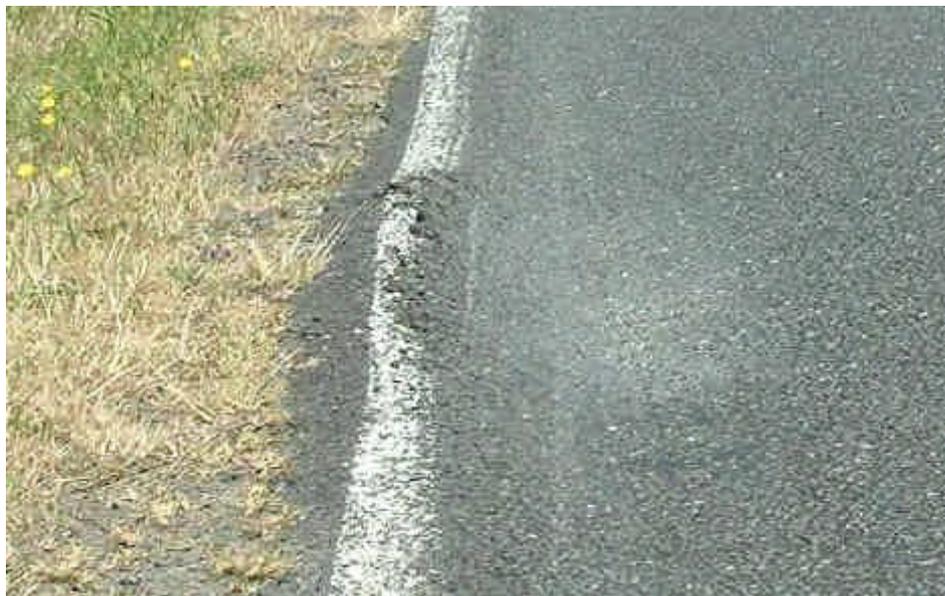
Shoving occurs when material is displaced to form a bulge or heave alongside a depressed area as shown in the diagrams and photos. The length in metres is recorded.

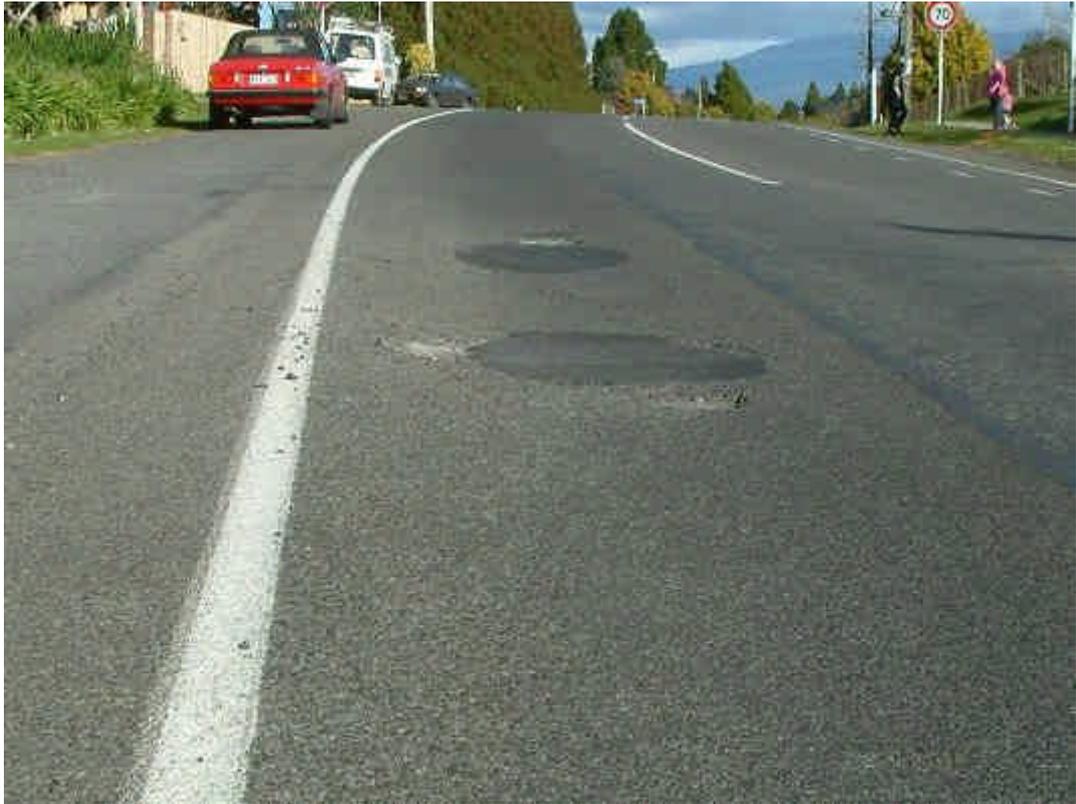
A large shoved area. The additional faults such as cracking, potholes and Patches are not recorded within the shoved area

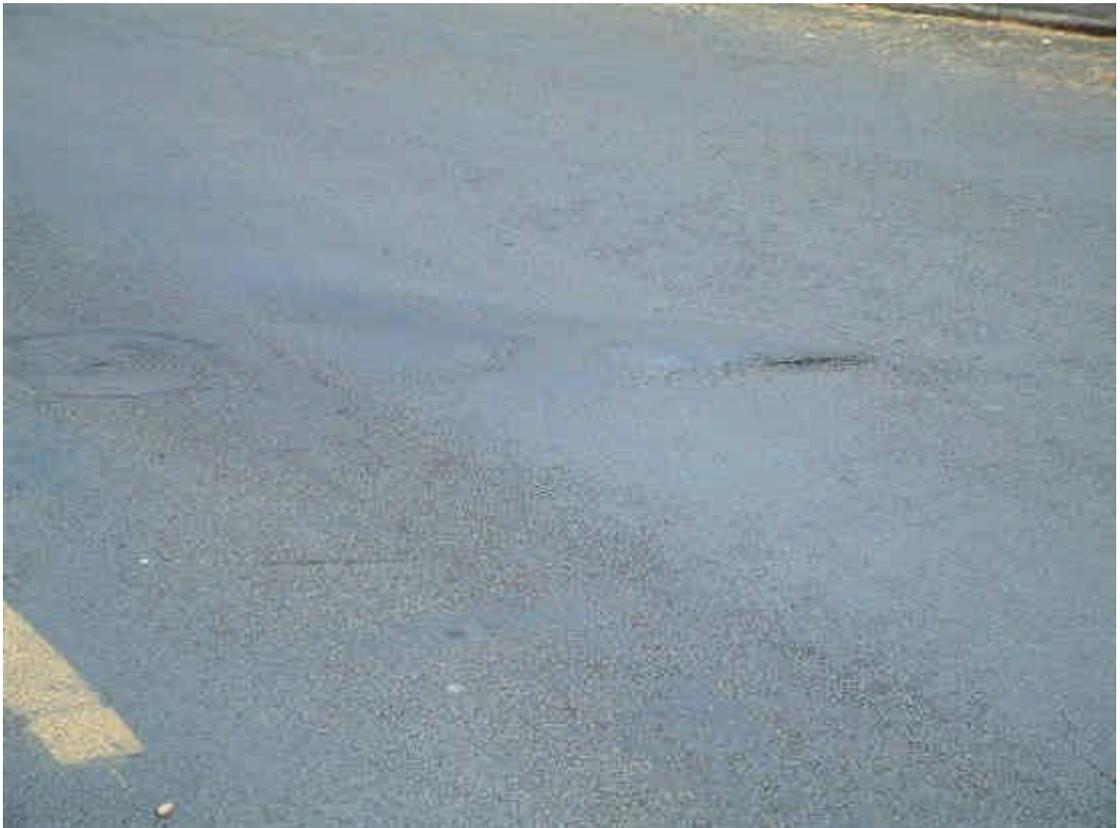
An abrupt shove near a service cover

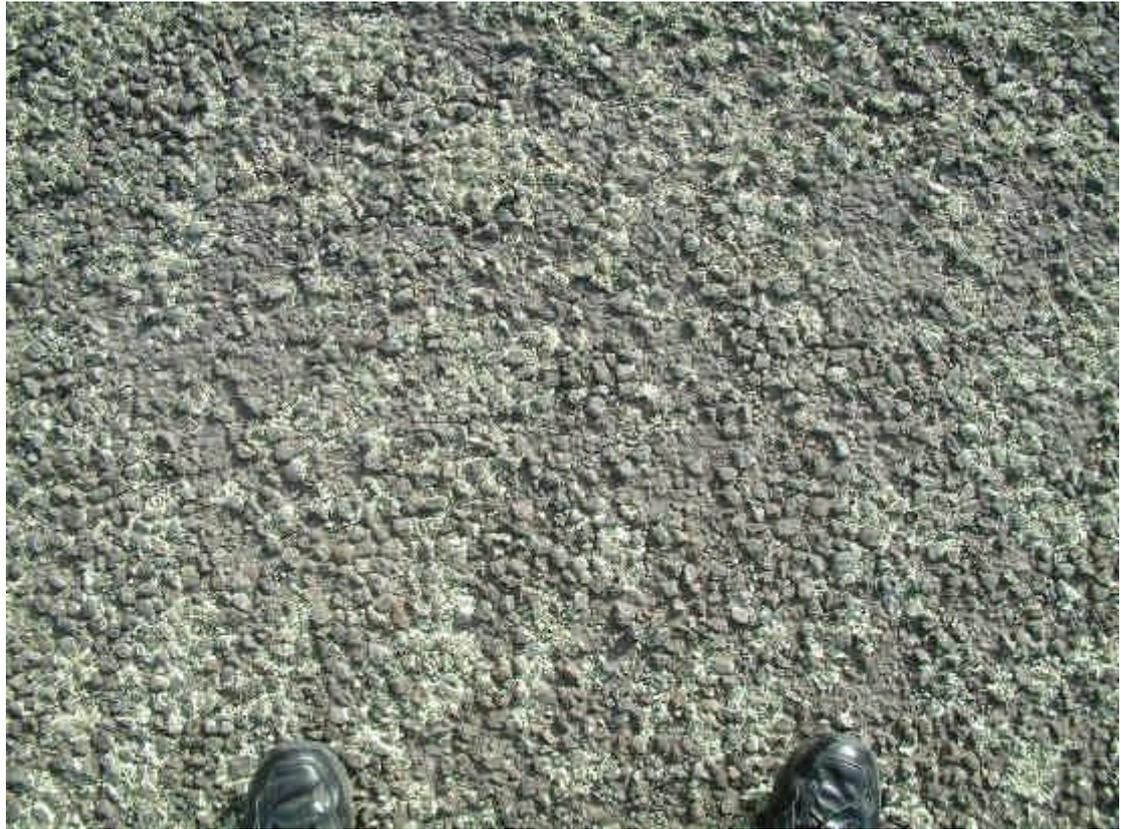
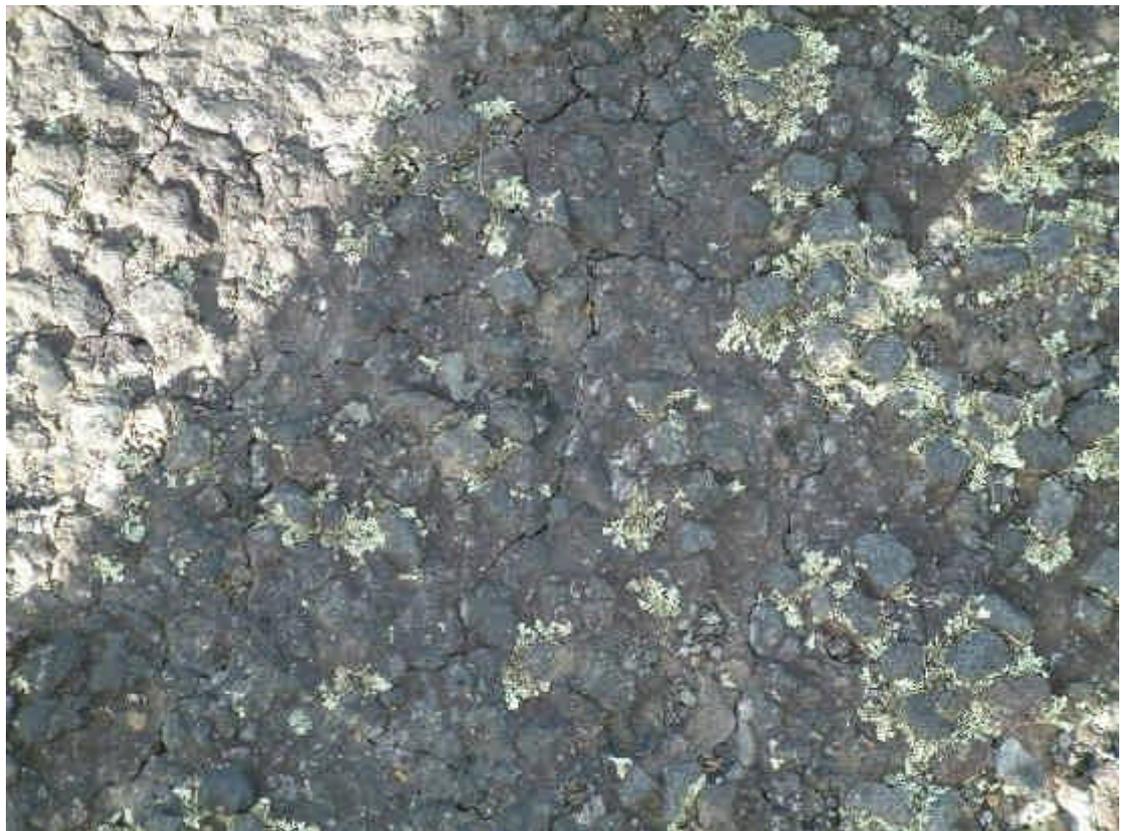
- (i) The two photos above are of the same areas of carriageway. The first photo is taken on a clear sunny day and the fine alligator cracks are nearly impossible to see. The second photo is taken in the same place but shading the surface and the alligator cracking is now very obvious.

In bright sunshine fine alligator cracks are much harder to see due to expansion of the carriageway surface and glare off the surface. But looking into your shadow, cracks can usually be observed as shown in the photos.

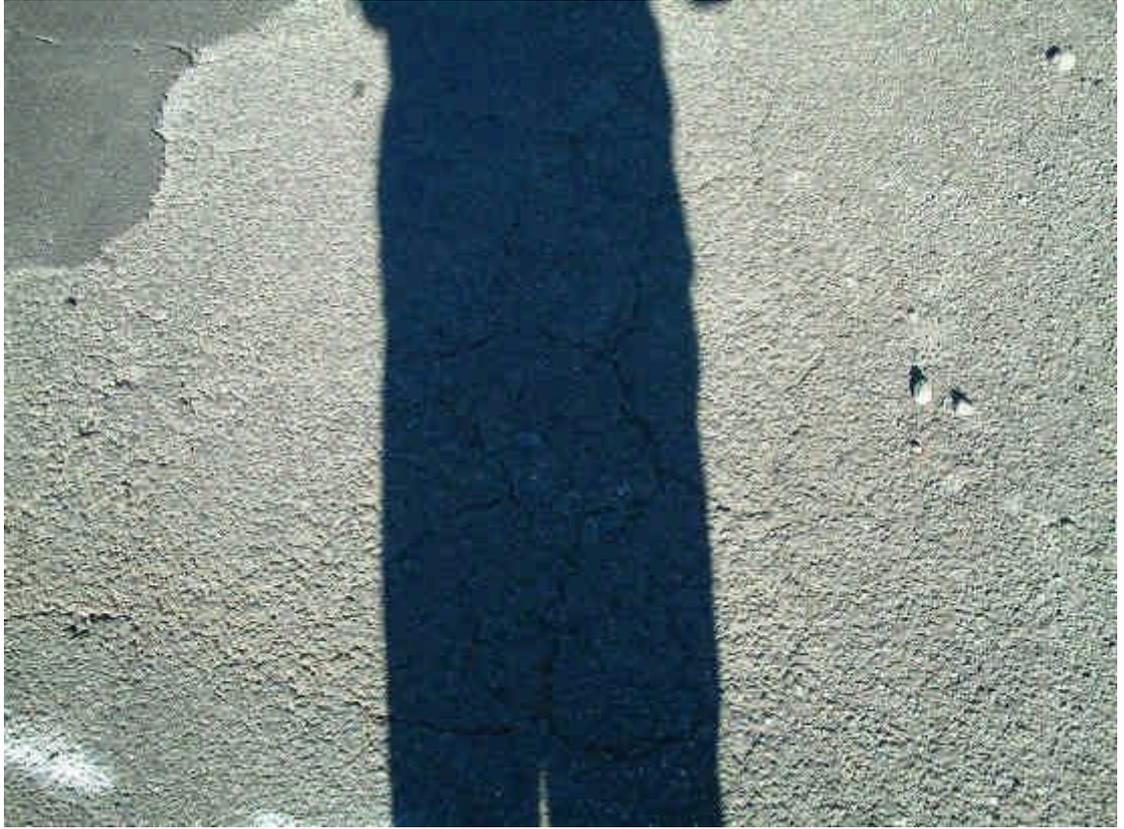
Alligator cracking is to include all irregular polygon shaped cracking irrespective of the size of the polygons formed by the cracks. Any alligator cracking that is observed outside the main wheeltracks such as in bus bays and clearways is to be included in the rating.

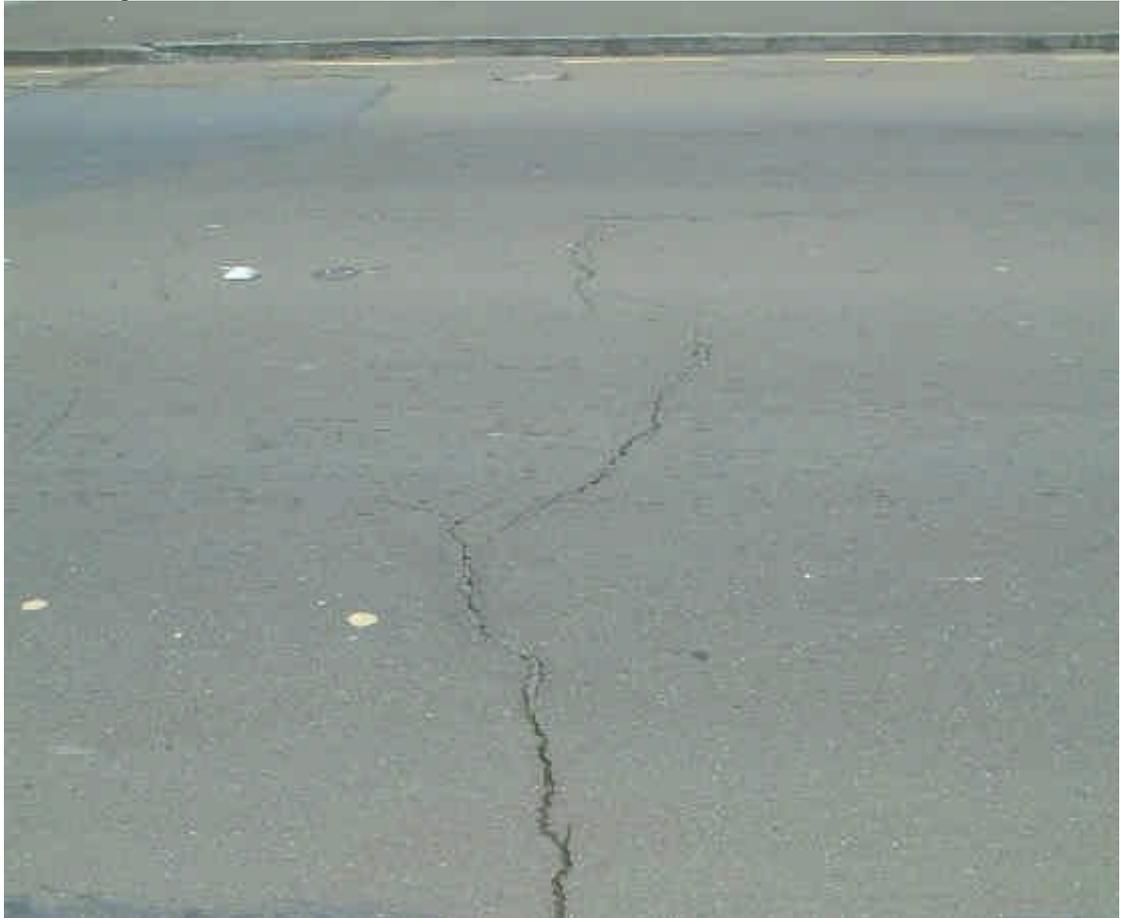
An irregular L&T Crack

The photo shows longitudinal and transverse cracks along and across the carriageway. Large rectangular cracks are to be included as these are just a more severe form of longitudinal and transverse cracking, which has extended to form a network. The total length in metres of cracking is to be recorded for this rating.

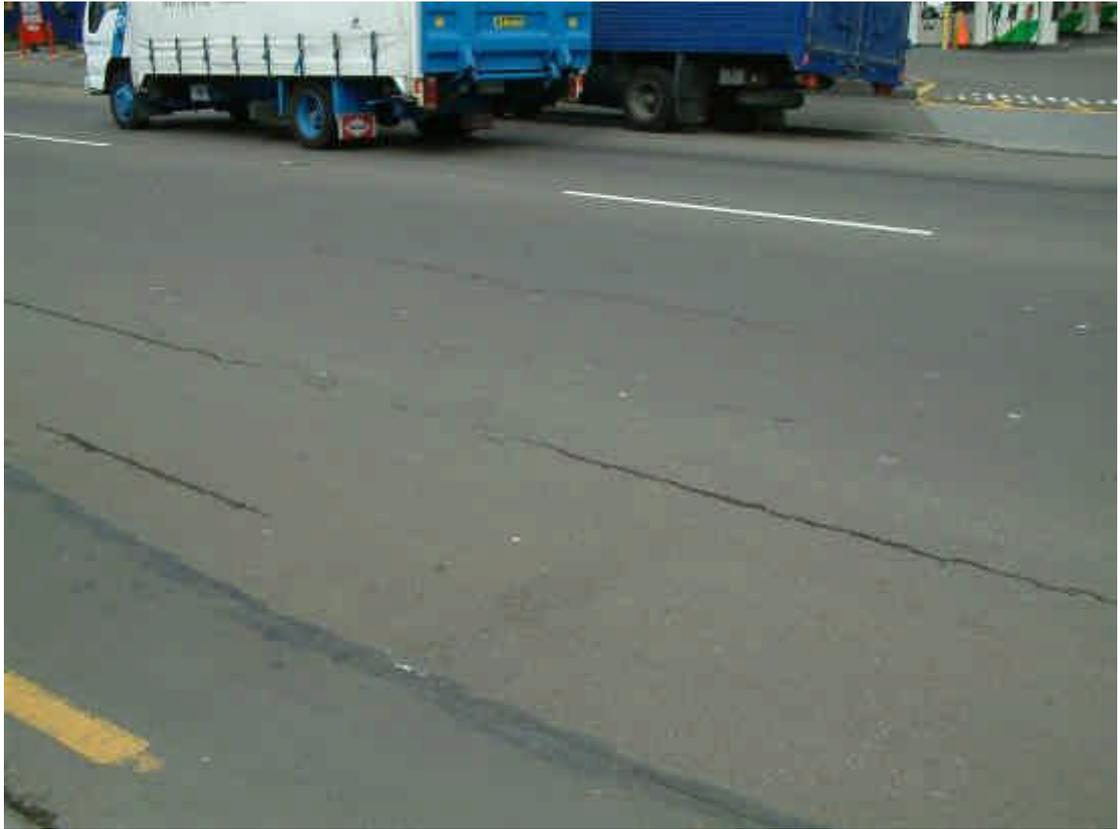
Straight L&T Cracks

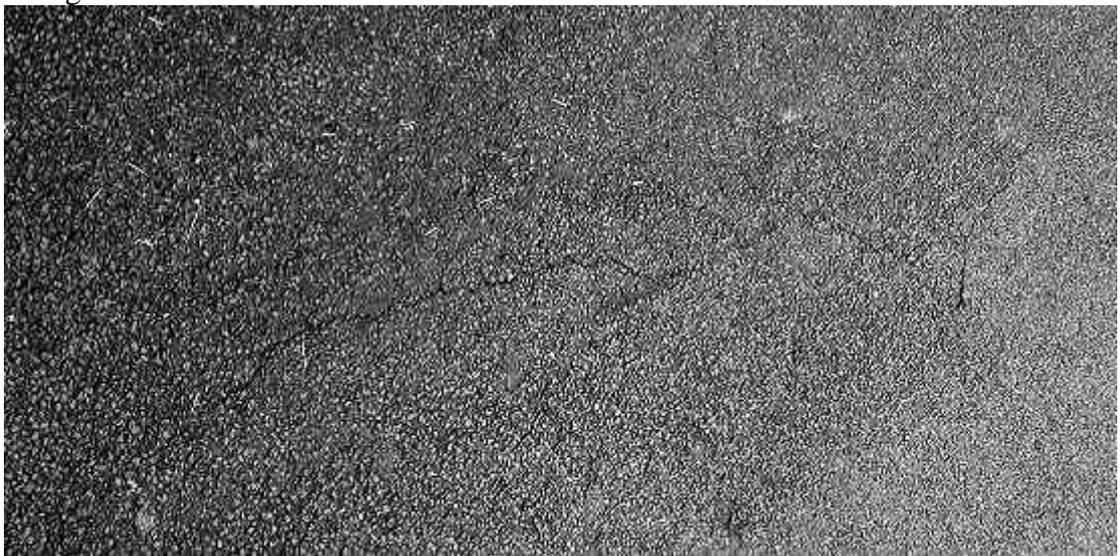
A small irregular L&T crack

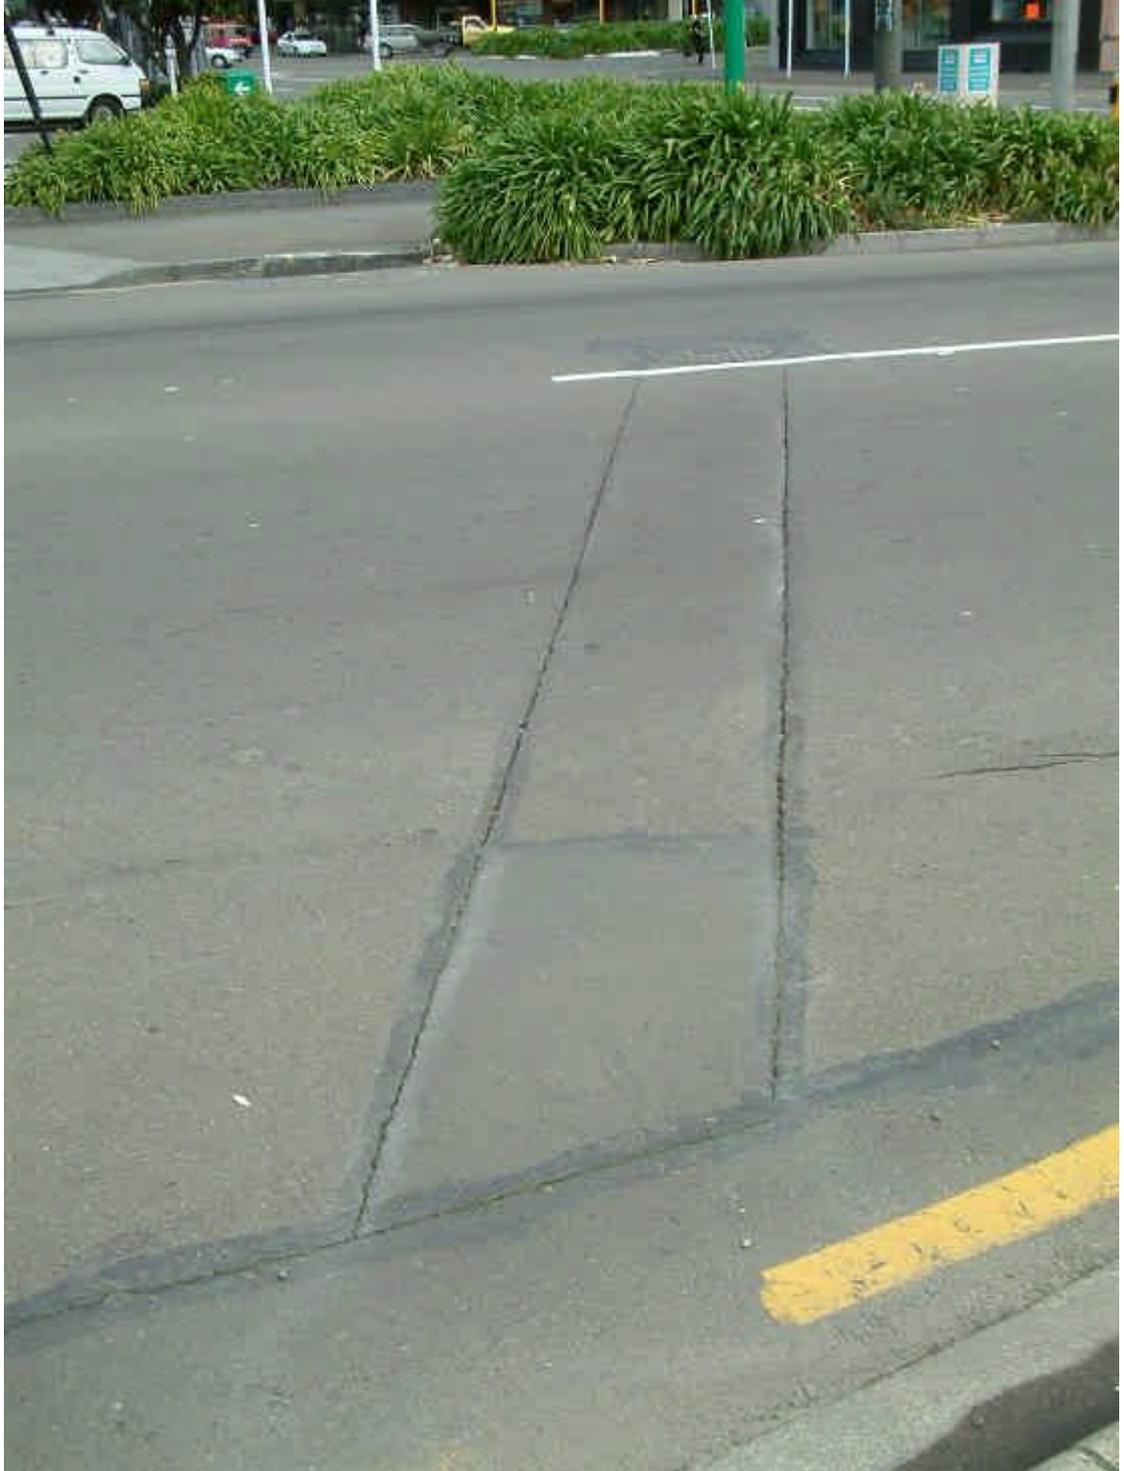
(iv) Joints along service trenches.

Joint cracks are recorded where there is a *visible* joint between two surfacings such as a reinstated trench or repair, or a change in surface type. If a crack appears in a continuous surface, then it is recorded as an L&T crack.

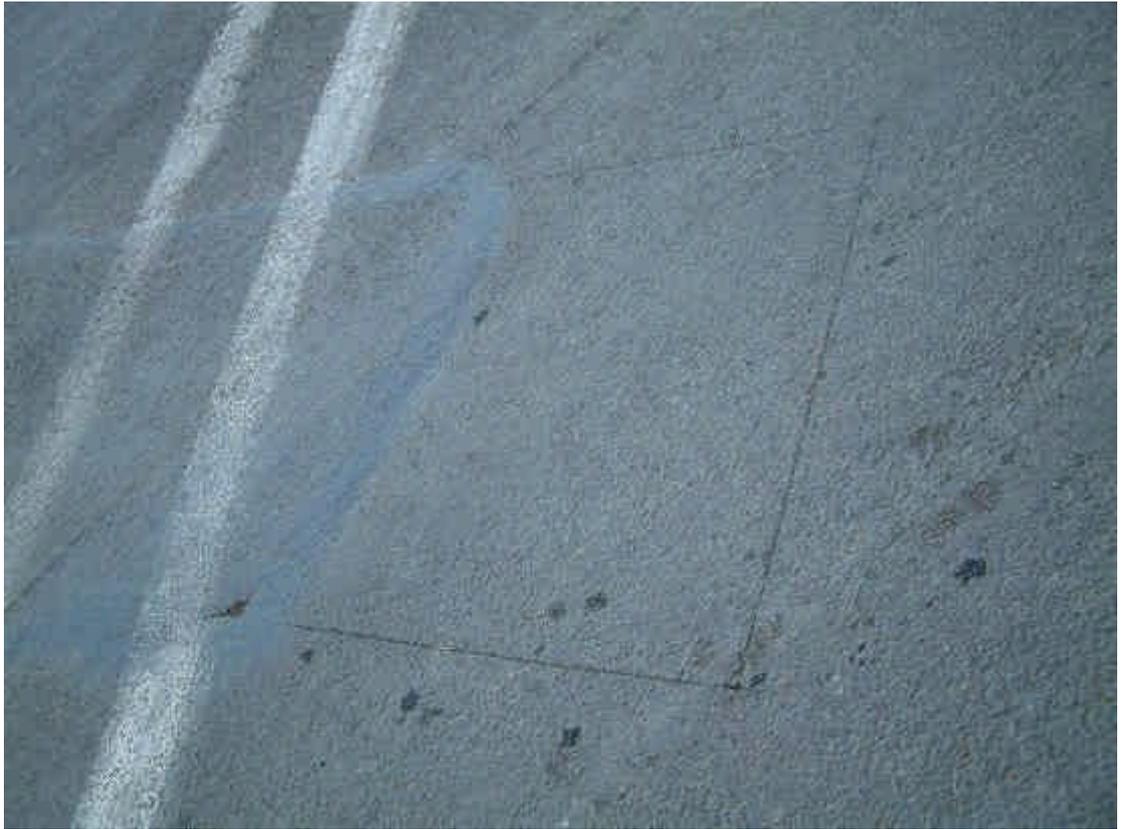
(v) Saw cuts, which have not been sealed also rate as joints.

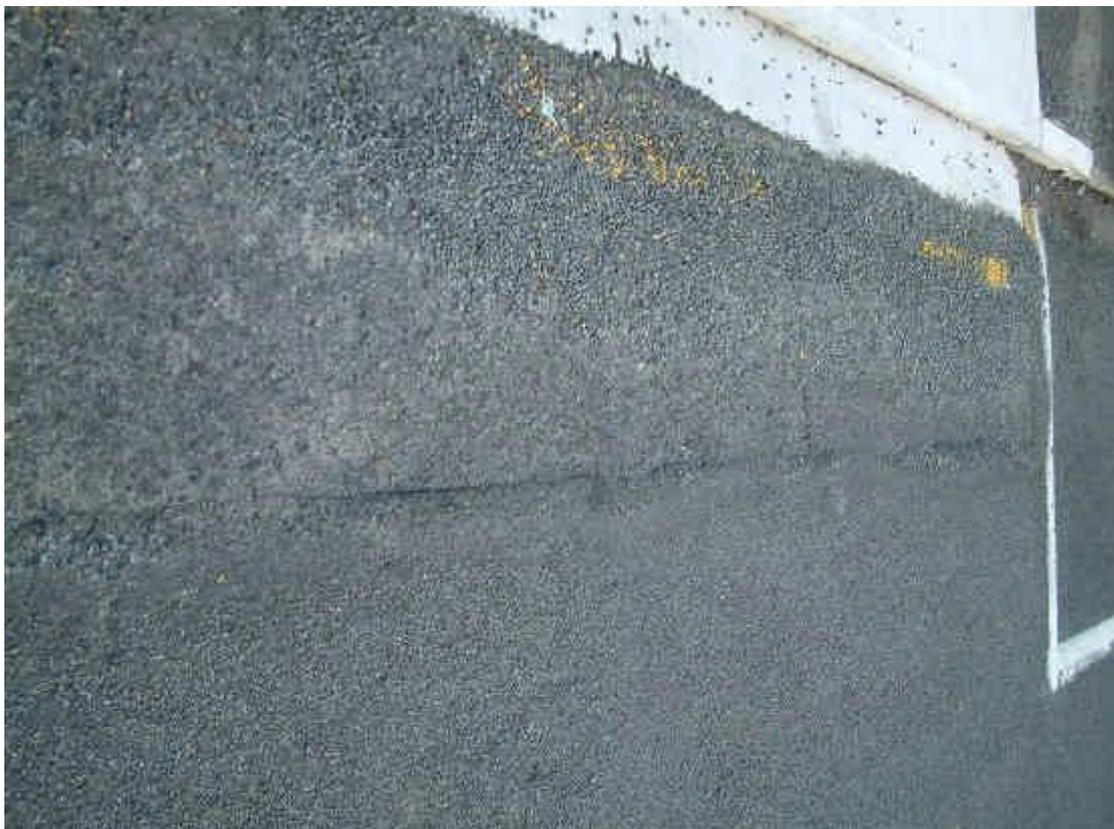
Joint Crack at the edge of a repair

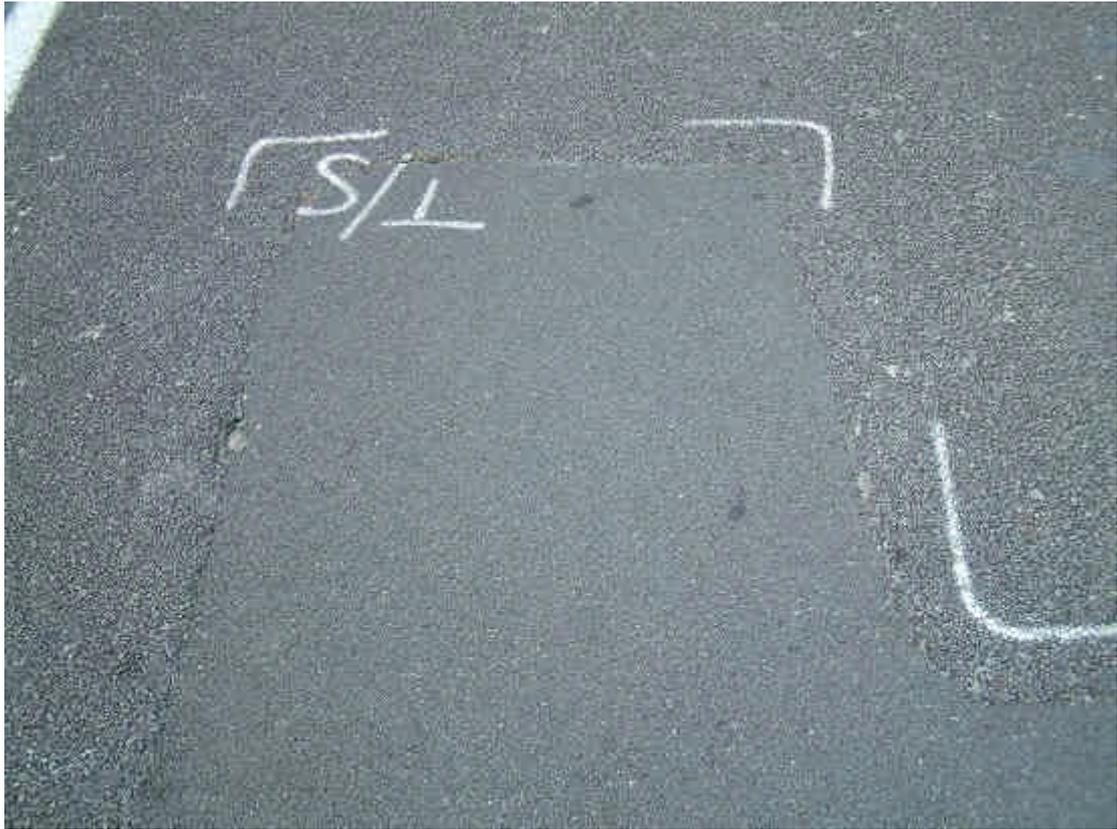
Joint Cracking around a patch

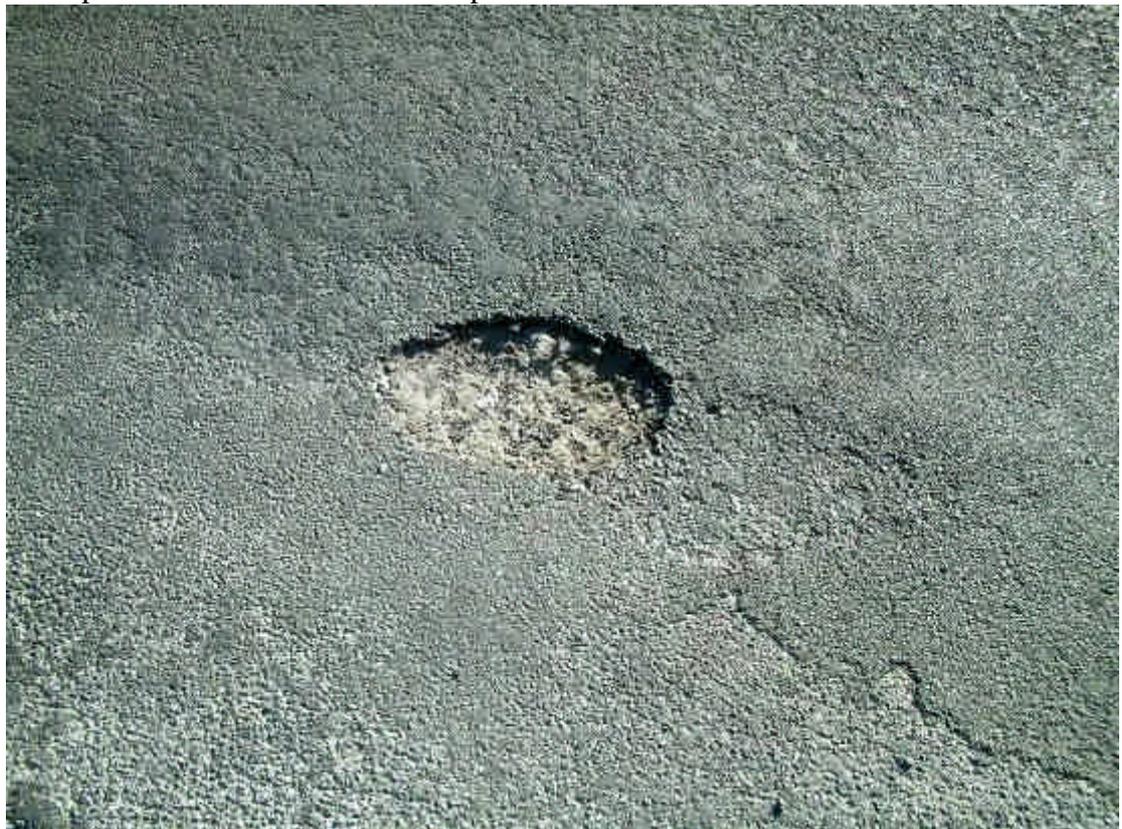
(i) A typical example of a pothole in chipseal surface.

This rating records the number of potholes where the surfacing has broken to the extent that the layer (usually aggregate) below the surface is exposed. The break must have a maximum dimension of 70mm or more to be rated as a hole. The rating for potholes is a count of the quantity.

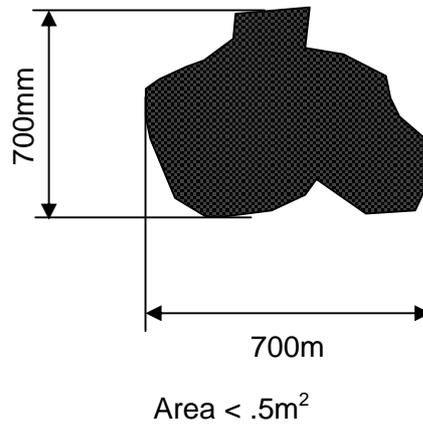
Pothole patches in a Chipseal

This rating records the number of pothole patches. An example is shown below. A patch is only recorded as a pothole patch where it is less than 0.5m^2 in area.

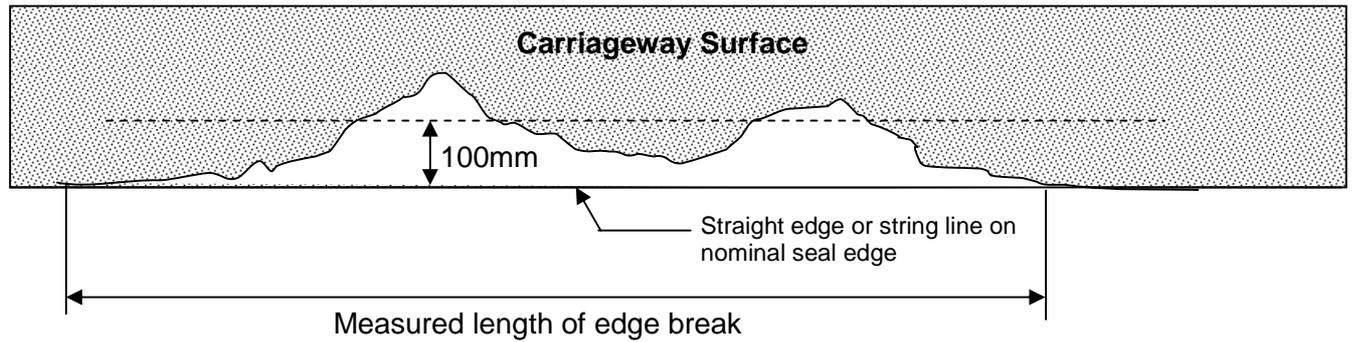
Edge break is the failure of the pavement along the edge of the sealed surface where there is no surface water channel present. Edge break will be rated if the seal width is reduced by 100mm or more from the nominal edge of seal. The length recorded shall be measured from the start of the taper leading up to the 100mm+ edge break to the point where the broken edge rejoins the line of the nominal seal edge as shown in the diagram and photo below.

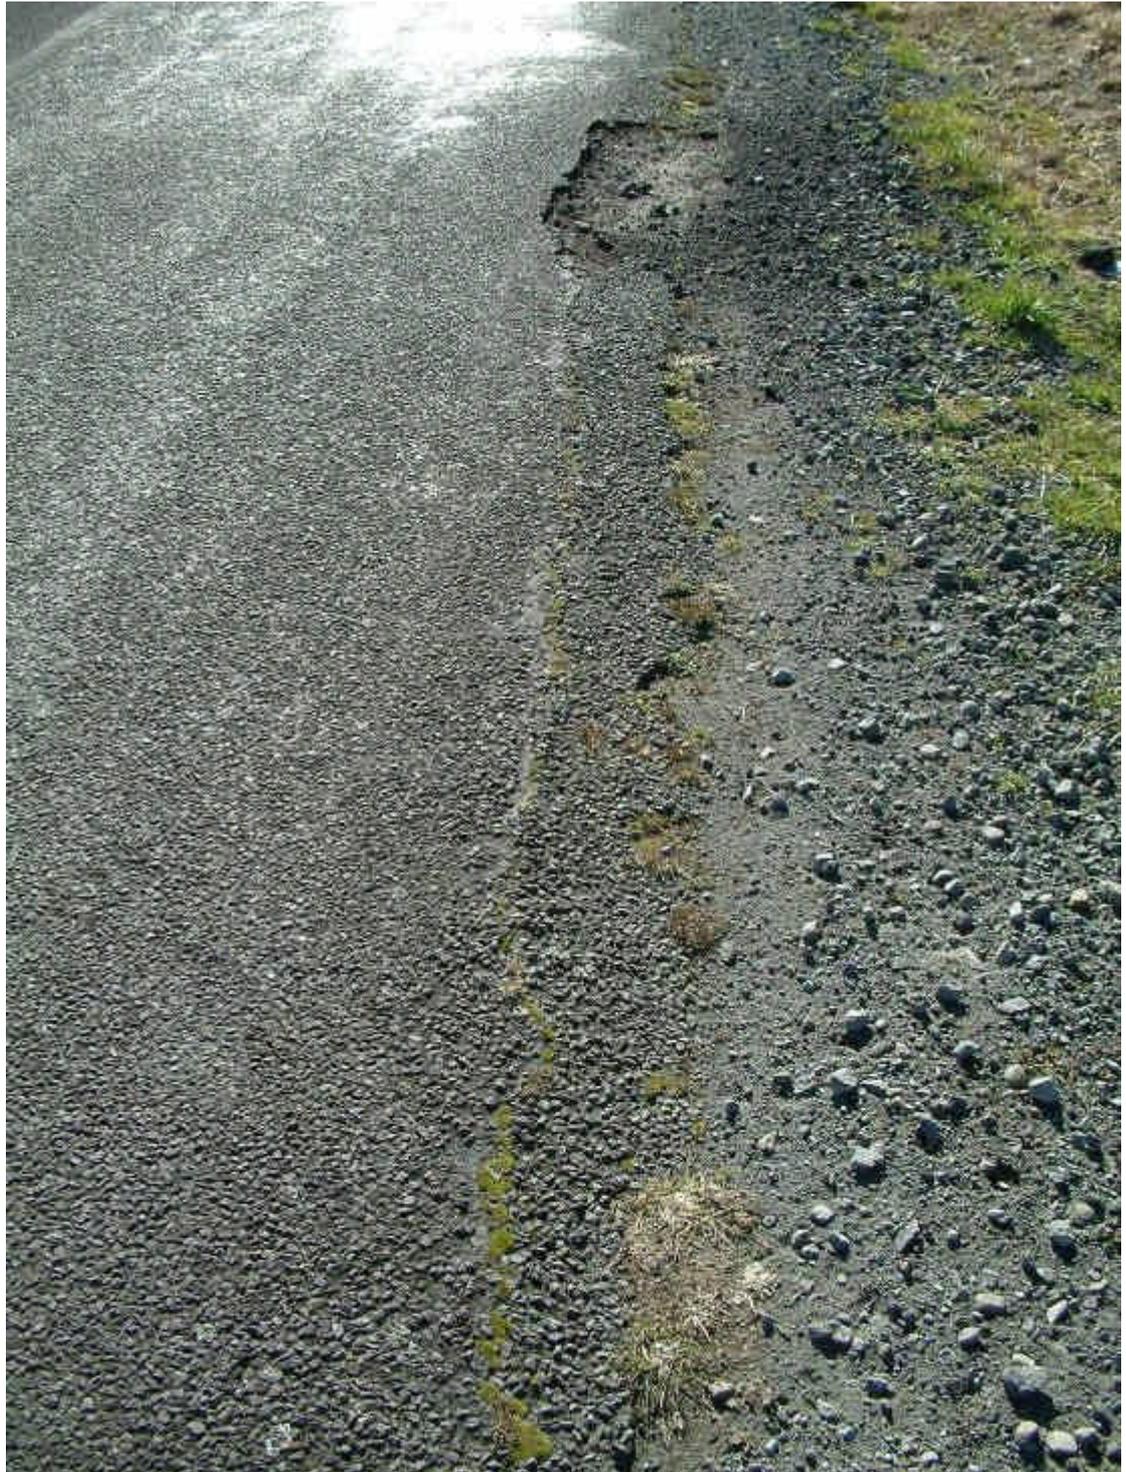
- (i) Edge break along a chipseal carriageway showing a reduction in seal width of greater than 100m.

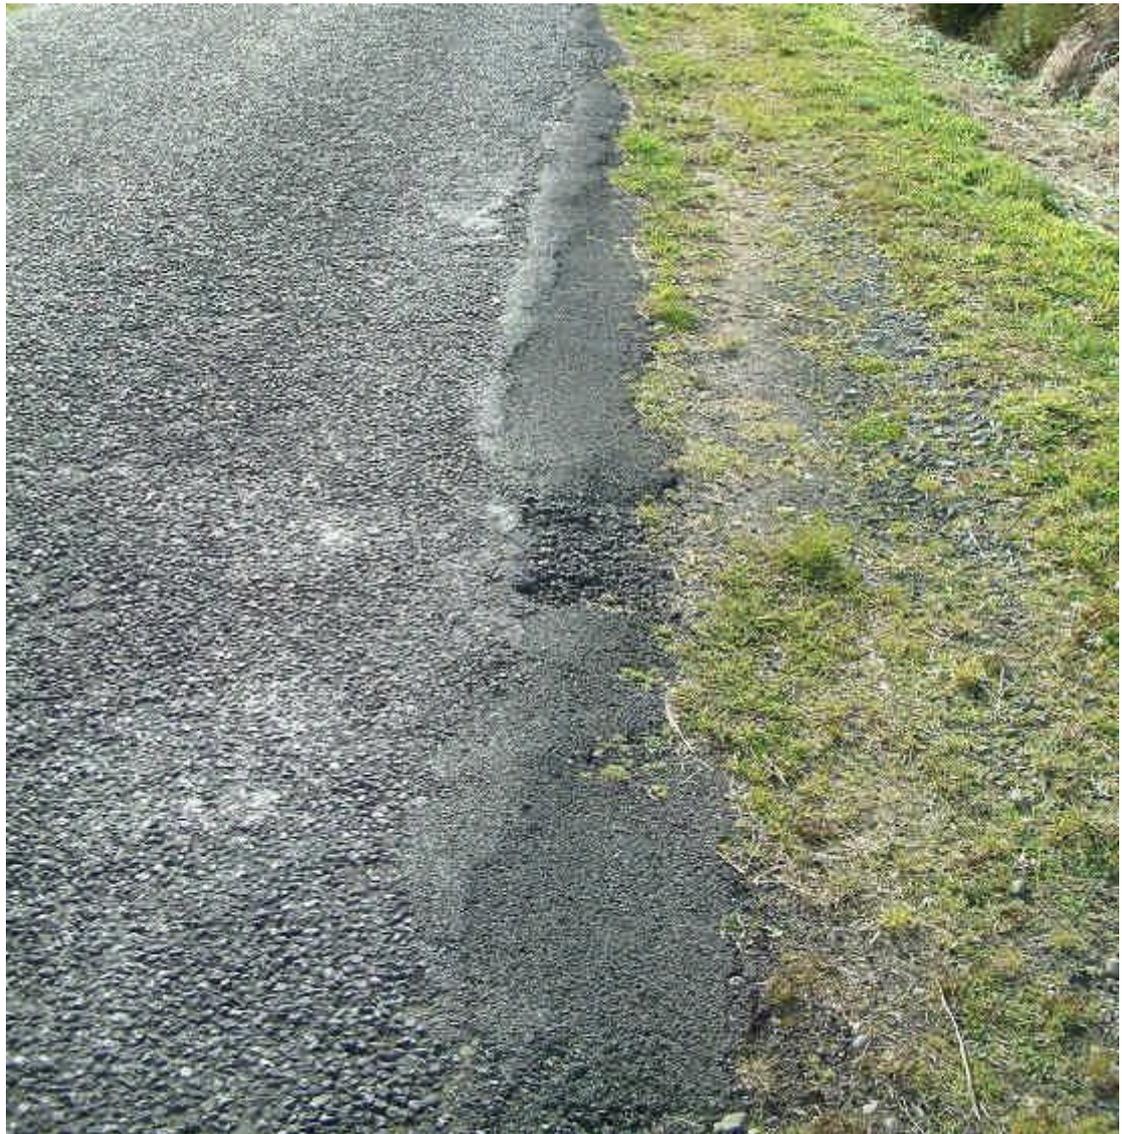
(i) Edge break patches.

Edge break patches appear as narrow repairs at the edge of seal. Usually patches are easily identifiable as edge break that has been patched. The same rating criteria as edge break applies.
