RAMM ROAD CONDITION RATING & ROUGHNESS

ROAD ASSESSMENT
AND MAINTENANCE
MANAGEMENT SYSTEM

PFM 6

RAMM - ROAD CONDITION RATING AND ROUGHNESS MANUAL

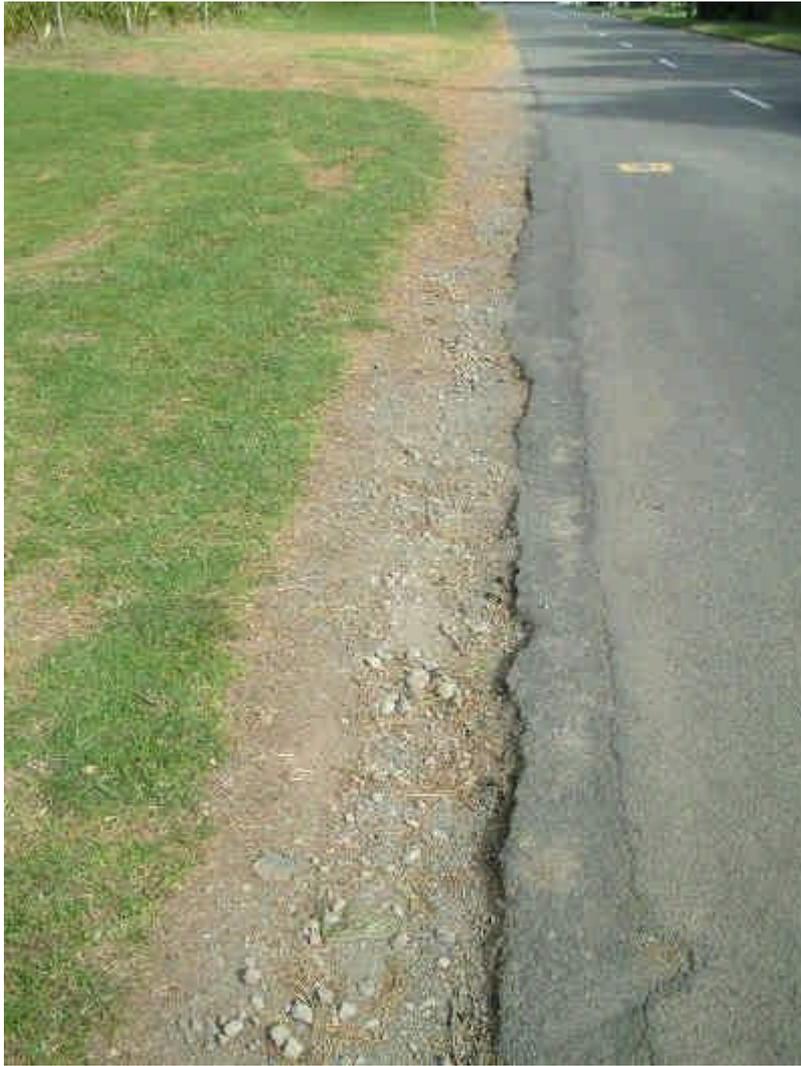
(ii) Edgebreak patch with edgebreak.

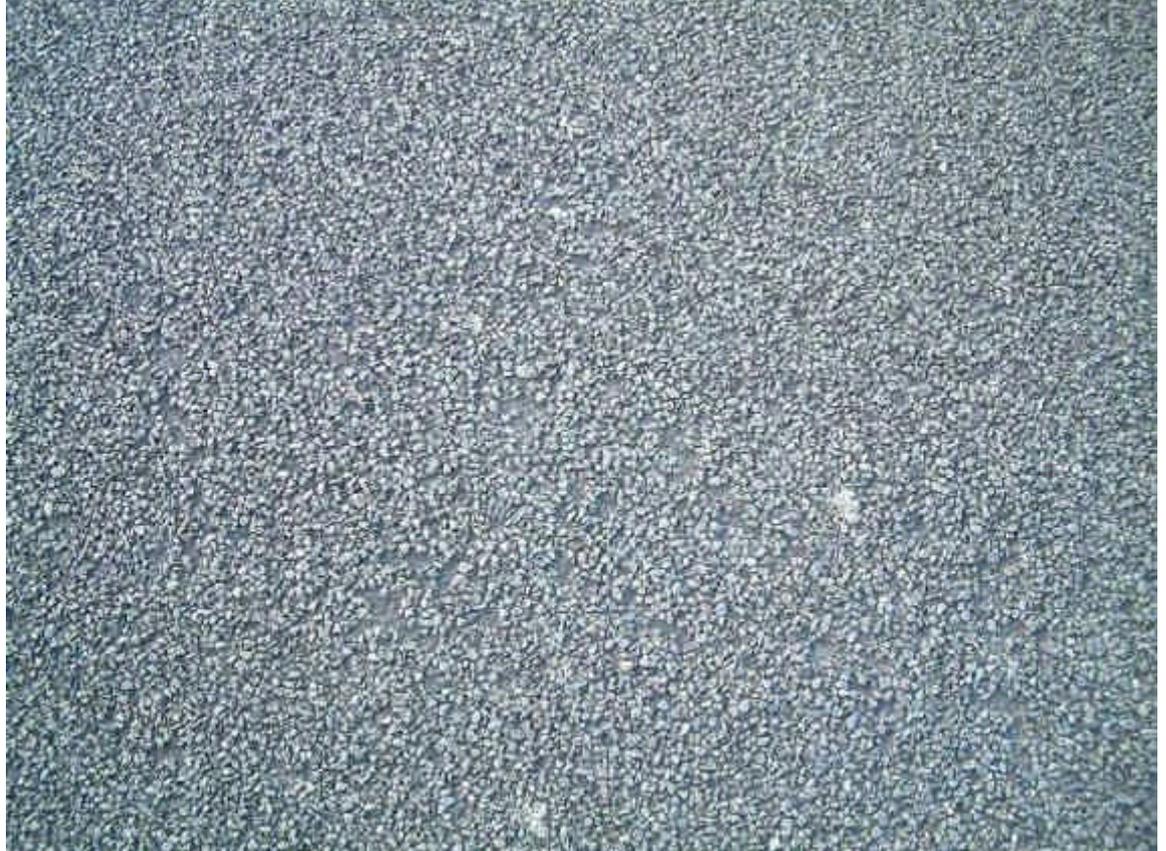
(i) A chipseal showing 10% chip loss.

Scabbing occurs when sealing chips have become separated from the bitumen in a chipseal. In an asphaltic concrete pavement the aggregate loss from the mix is called ravelling and is rated as scabbing. The carriageway is to be rated as scabbed when it has a chip or aggregate loss of 10% or greater. The following photos show a seal with a 10% chip loss, a seal with greater than 10% chip loss and an asphaltic concrete pavement showing signs of ravelling.

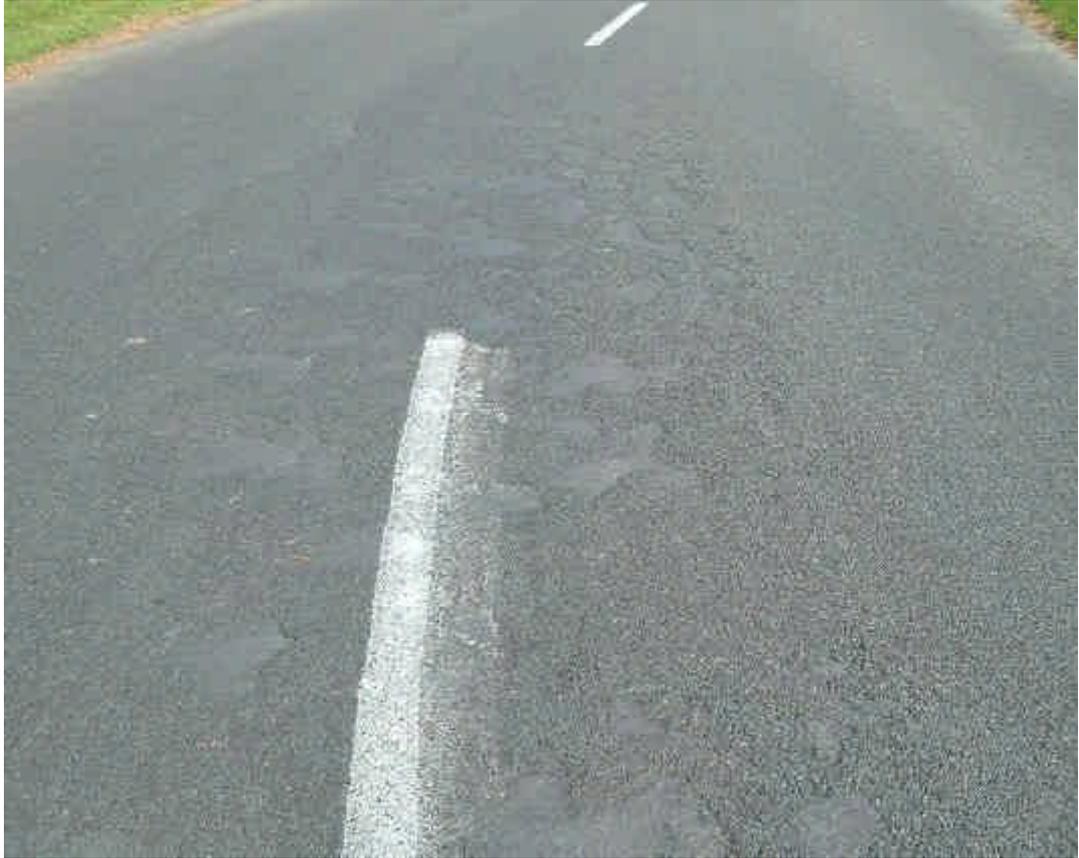
(ii) A chipseal with greater than 10% chip loss in large areas

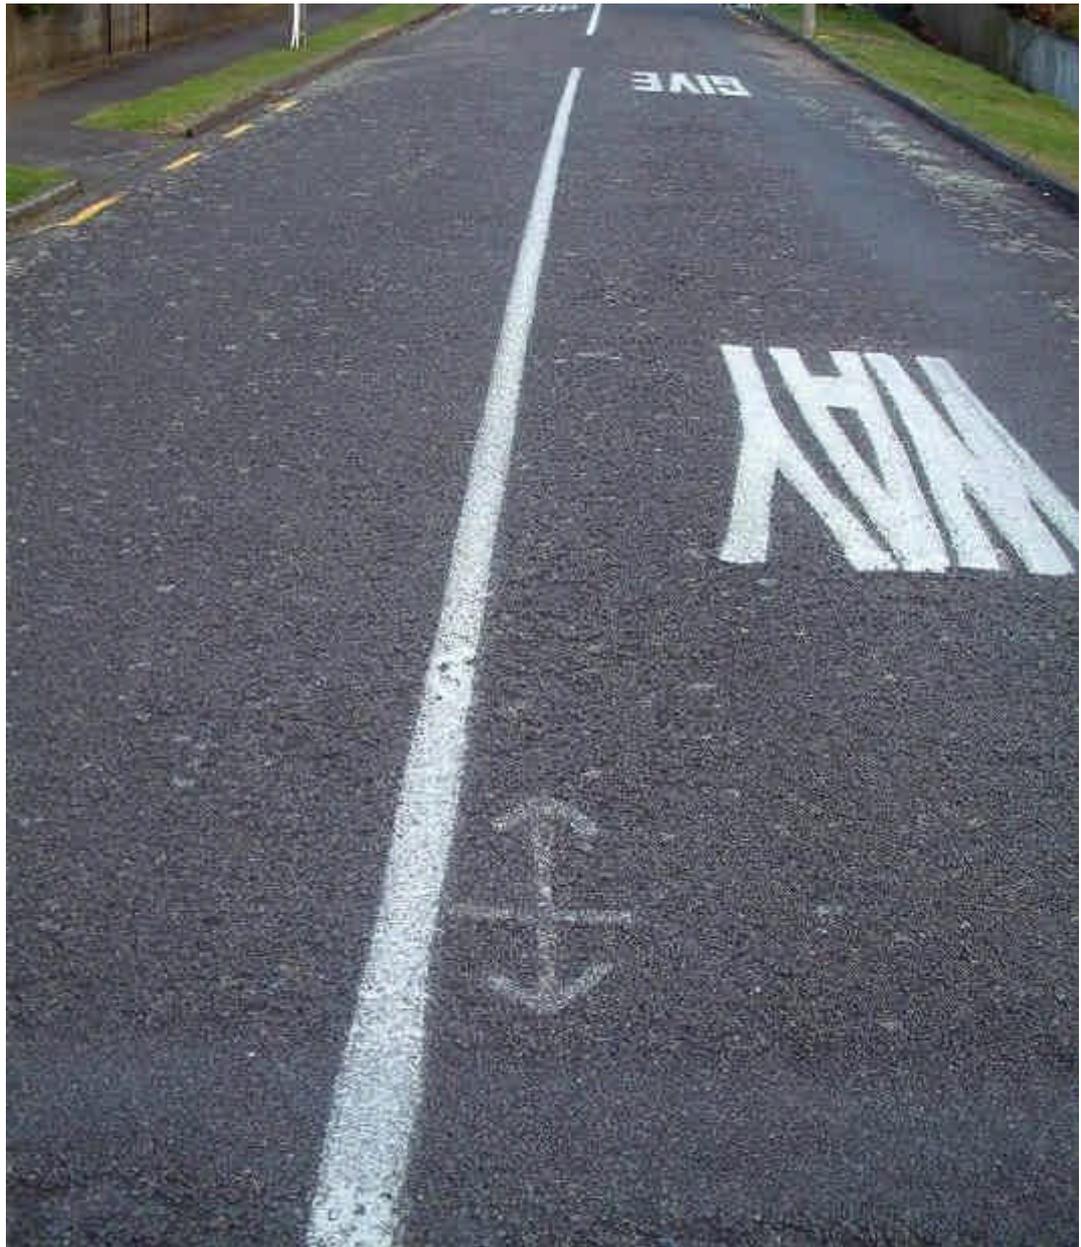
Widespread scabbing

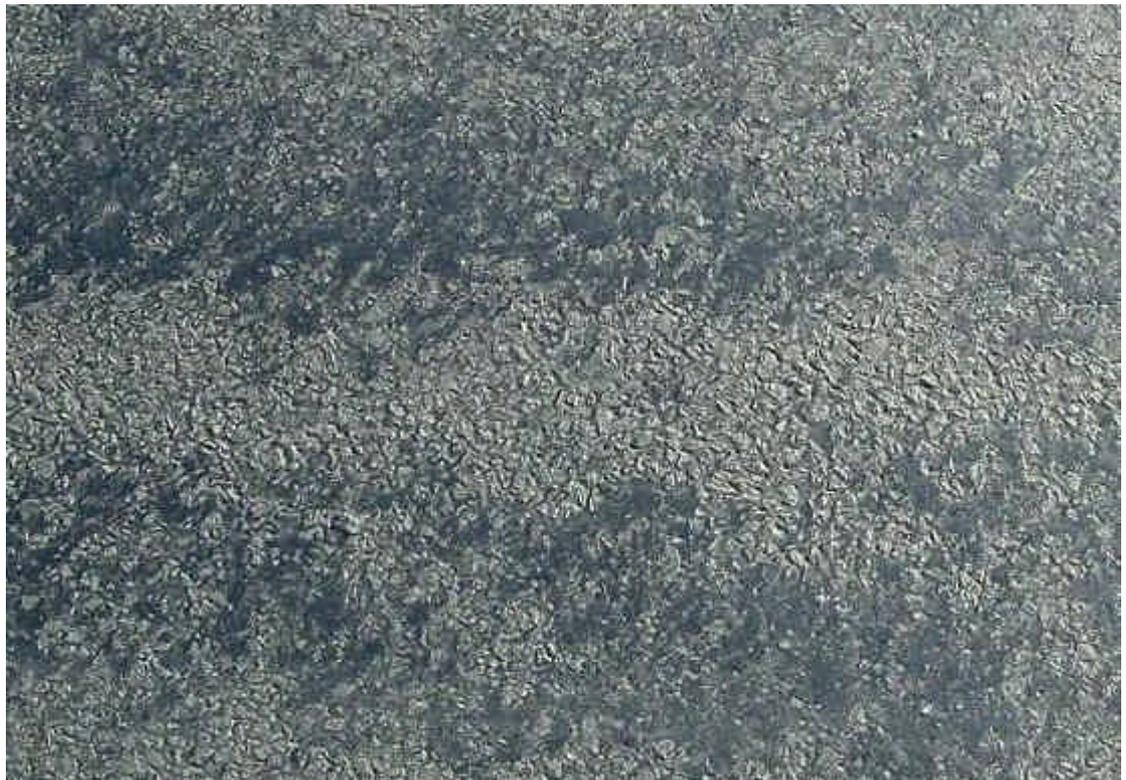
The photo above shows a close up view of a flushed wheelpath.

Flushing occurs when the bitumen has risen to where the surface aggregate is just protruding (about 2mm on grade 3 and 4 chip seals) or where the binder has risen to be level with or over the top of the surface aggregate. In most cases where flushing is present, all three of these conditions will exist. Flushed areas are characterised by a generally shiny or slick appearance and a lack of surface texture.

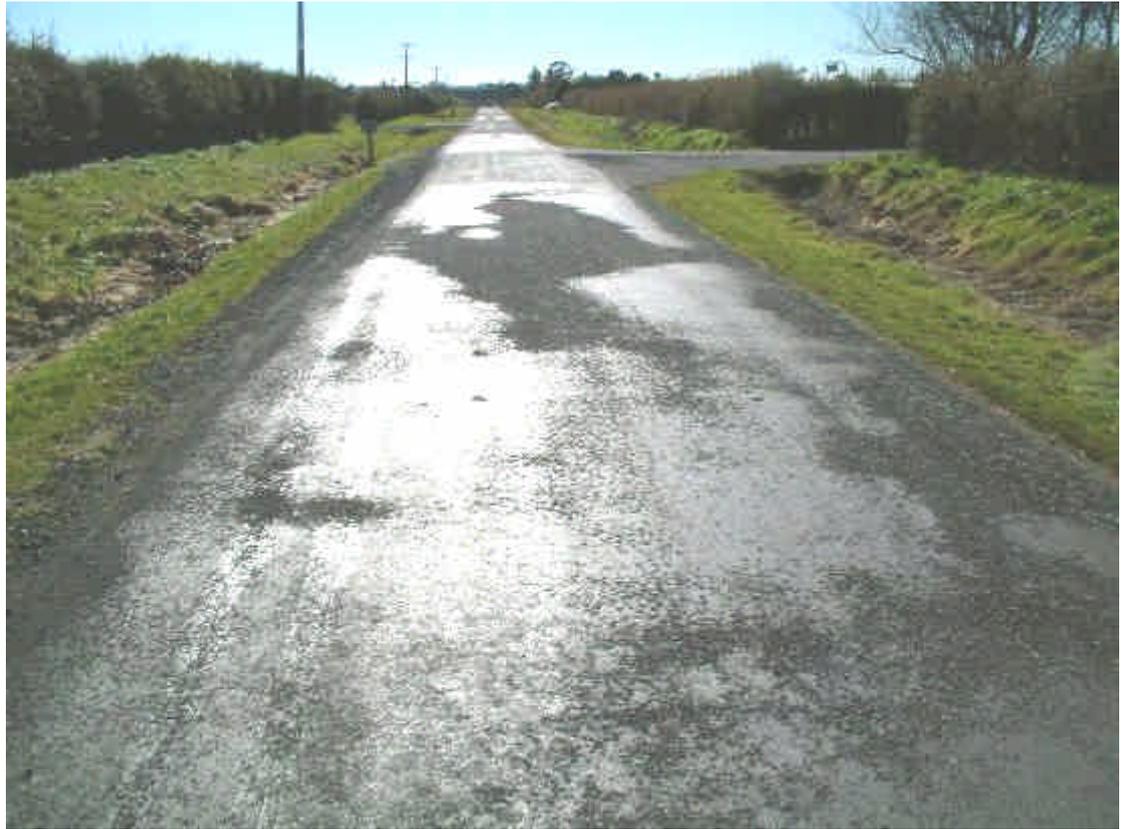
A general view of carriageway with extensive flushing in the wheelpaths.

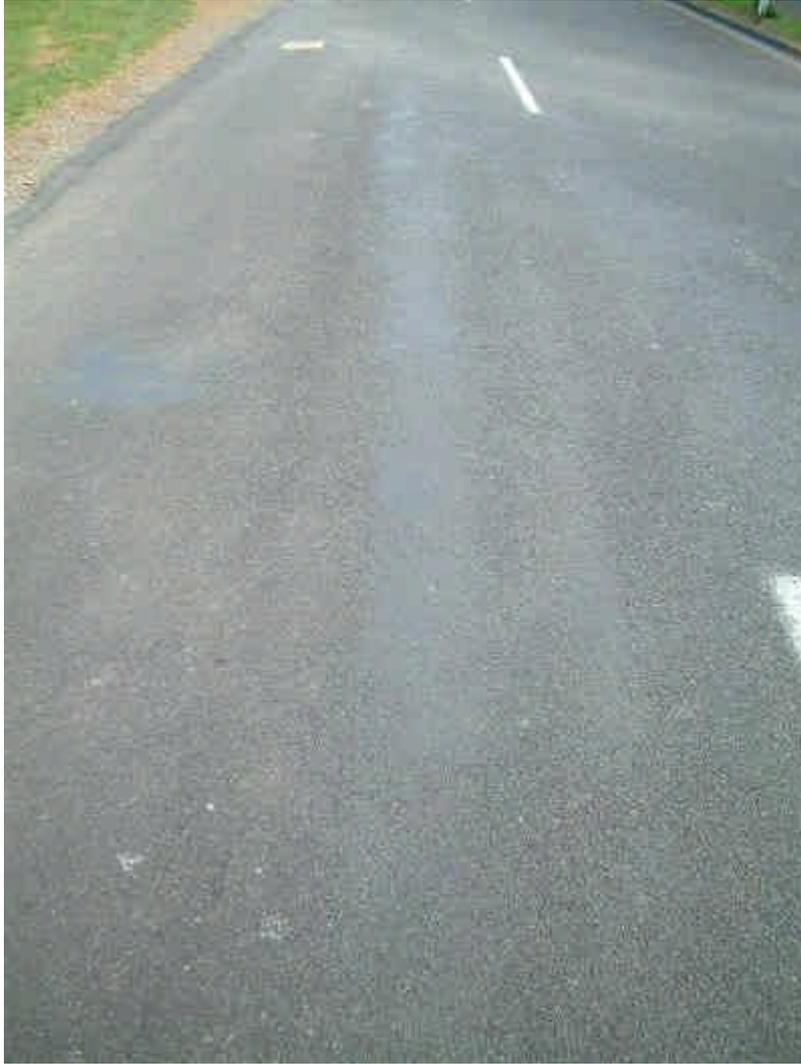
- (i) Marginal Flushing. The carriageway surface shown above is just showing signs of flushing with the binder just below the top of the aggregate. .

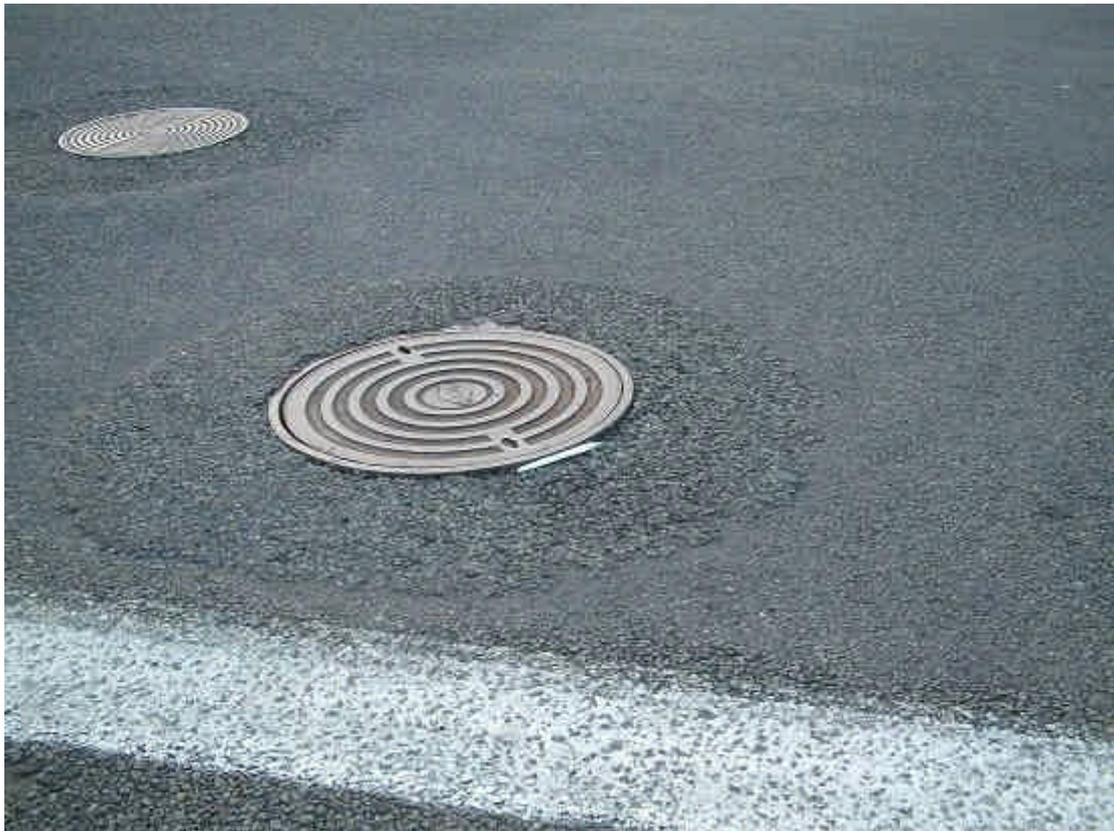
High Service cover 20mm above the carriageway and in the wheelpath.

This rating records the number of service covers, (hydrants, manholes, etc) and service trenches that run across the carriageway, are in the wheelpath and are 20mm or more higher or lower than the carriageway surface

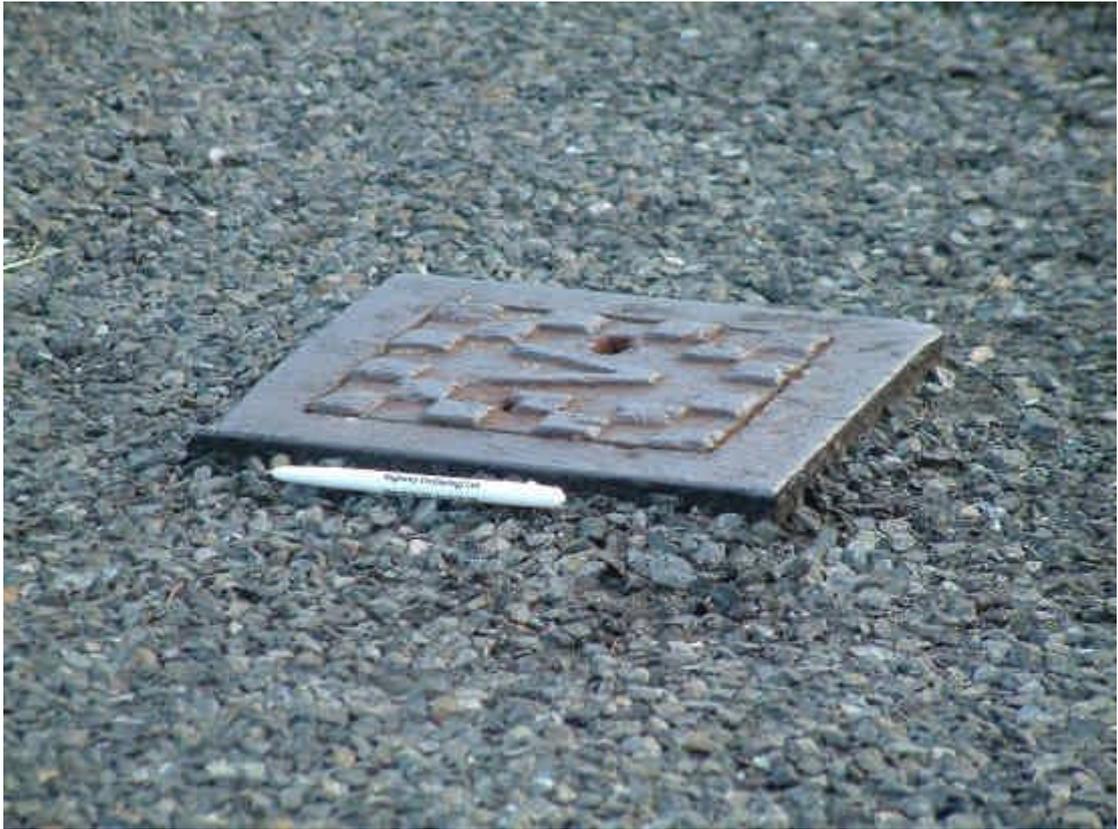
High Service cover.
