# WoF news

NZ TRANSPORT AGENCY  
WAKA KOTAHI

Issue 16 February 2012

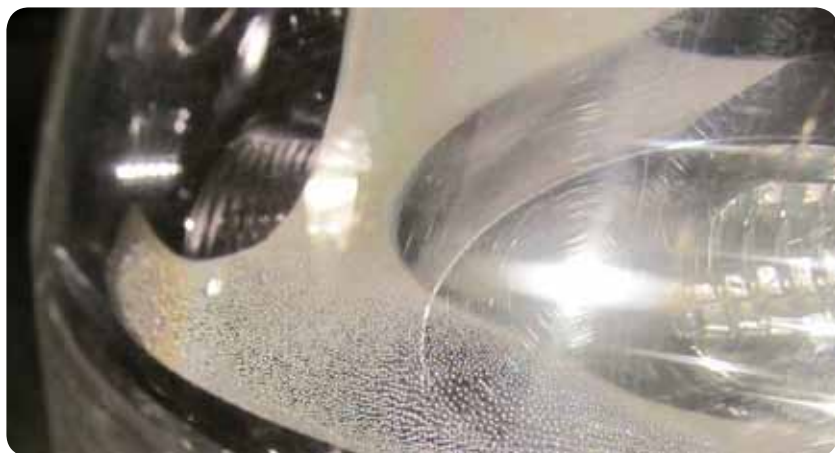
- PASS - light moisture in the form of fog or fine mist (small droplets) is considered normal and will usually disappear with the lamps or vehicle being used, but sometimes not during a normal vehicle inspection. This type of moisture is acceptable for WoF/CoF and must be passed. Refer to Figure 1.
- FAIL - heavier moisture in the form of large droplets, runs or puddles tends to indicate a problem with the lamp, such as a water leak. This type of moisture is NOT acceptable for WoF/CoF and must be rejected. Refer to Figure 2.

Figure 1: Light Moisture - fog or fine mist (small droplets) - PASS

Most exterior lamps are vented to atmosphere (unsealed) to allow for changes in pressure and prevent damage to the lamp. This means that air, which contains moisture, can enter the lamp. When there is a difference in temperature between the inside and outside of the lamp, the moisture can appear as fog or fine mist inside the lamp.

**Note:** The above pass/fail criteria apply to all lamps (including sealed lamps) where the VIRM currently requires you to fail a vehicle for visible moisture.

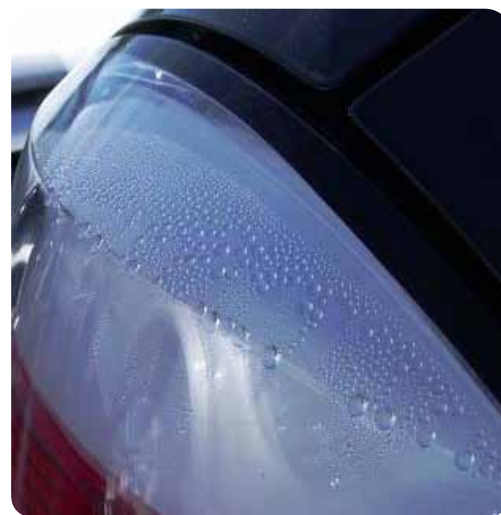
Figure 2: Heavy moisture - large droplets - FAIL

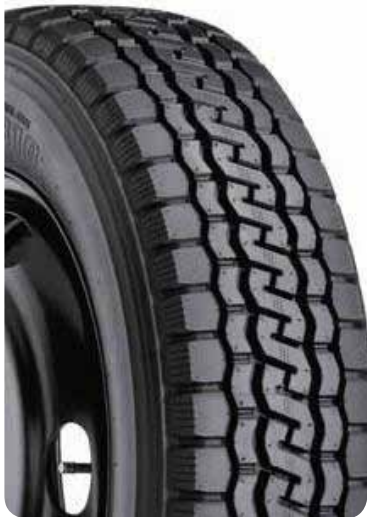
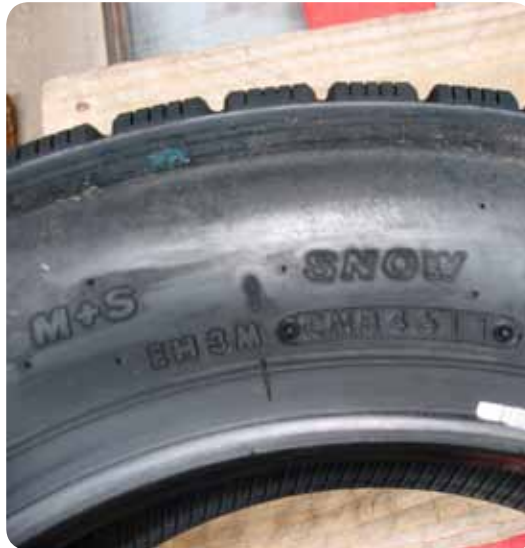
Bridgestone M810 - not a winter tyre

The tyre has the word SNOW and M+S written on the side (see pictures below), but it has neither the distinctive winter tread

pattern, nor is it marked with the word STUDLESS and/or the snowflake/mountain symbol. Therefore, the Bridgestone M810 tyre is NOT a winter tyre. For more guidance on winter tyres, please refer to the **VIRM: In-service**, or the **winter tyre pamphlet**, or **WoF News 14** (August 2010).

Bridgestone NZ have advised NZTA that the above tyre has recently been failed as a winter tyre when the tyre is not actually a winter tyre, but an all-season tyre.

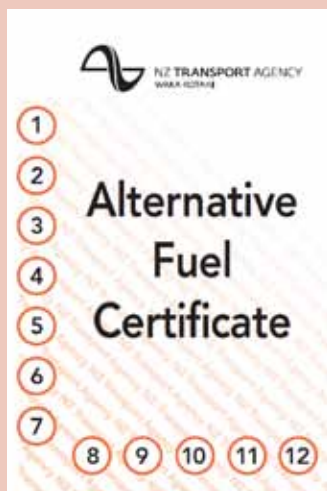
## New Alternative fuel label

We have finally brought the old MoT style alt fuel label up to the current NZTA style, see below:
