Interim Speed Management Plan Kerikeri Bay of Islands Catchment

Approved by Far North Distirct Council at an ordinary meeting dated 16 November, 2023

Author Organisational Solutions Ltd Local Government Planning and Resource Management	Shawn Baker	3 / 11 / 2023
	Elizabeth Stacey	3 / 11 / 2023

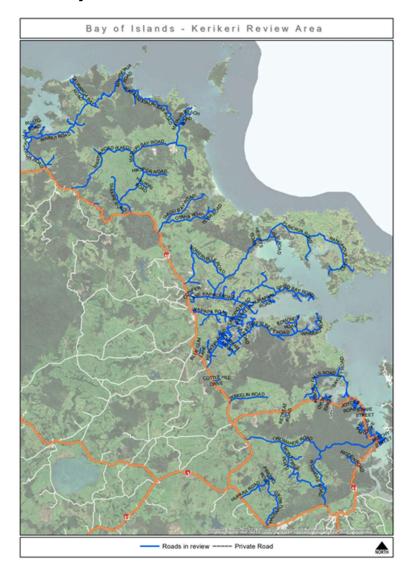
This Interim Speed Management Plan includes all roads to the east of State Highway 10 and extends from State Highway 11 in the south (Kawakawa – Opua) through to the Whangaroa Harbour in the north. and includes:

- Kerikeri urban area
- Opua
- Pahia
- Waitangi
- Haruru Falls
- Whangaroa

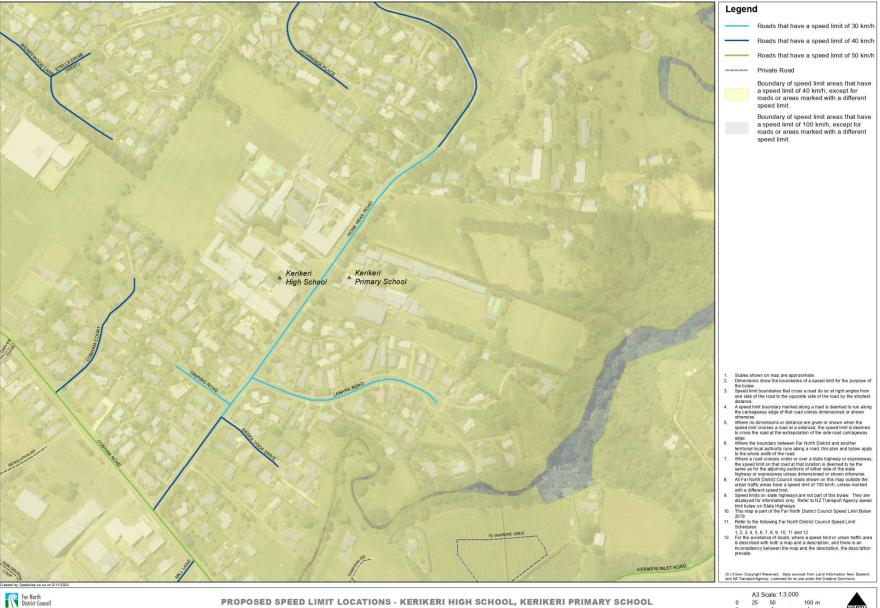
PROPOSED SPEED LIMIT LOCATIONS - KERIKERI HIGH SCHOOL, KERIKERI PRIMARY SCHOOL

30kph permanent speed limit on Hone Heke Road from Baska Voda Drive to 65 Hone Heke Road; Lanark Road; Turutaru Lane; and Oripiro Road.

Kerikeri Primary School is located on Hone Heke Road opposite Kerikeri High School. Both schools are Category 1 Schools. In addition to the main schools, there is an early childhood centre located on Lanark Road.

The following speed limits have been set for Kerikeri Primary School and Kerikeri High School:
