Trigger Inspection Report

This report summarises the monitoring required under Consent Condition SED.11(b) and relevant Project Management Plans.

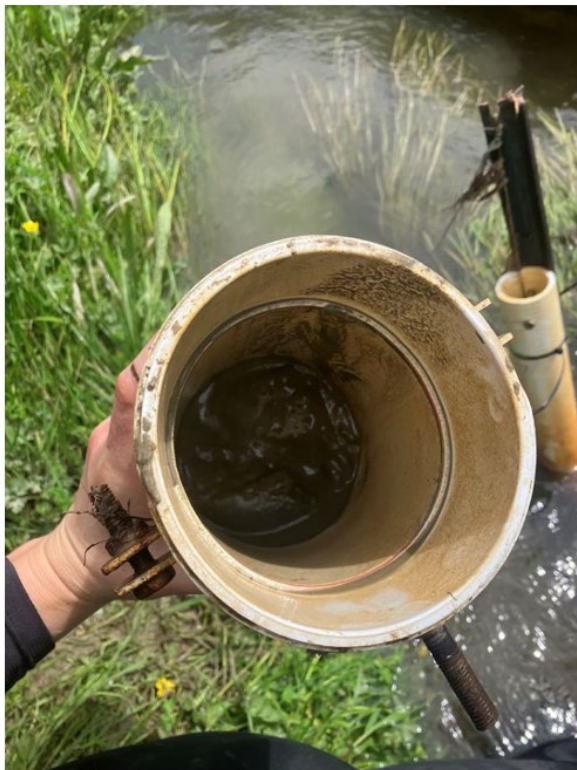
Upstream samples (WQ4) were determined to be invalid, as the lid of the in-stream sample container was damaged in the event. At least 3cm of silt was accumulated in the sample jar (see below). This has since been replaced to prevent recurrence.
