Te Ara Tūtohu

Waitara to Bell Block safety improvements

SH3/Princess Street roundabout and pedestrian underpass delivering safer journeys

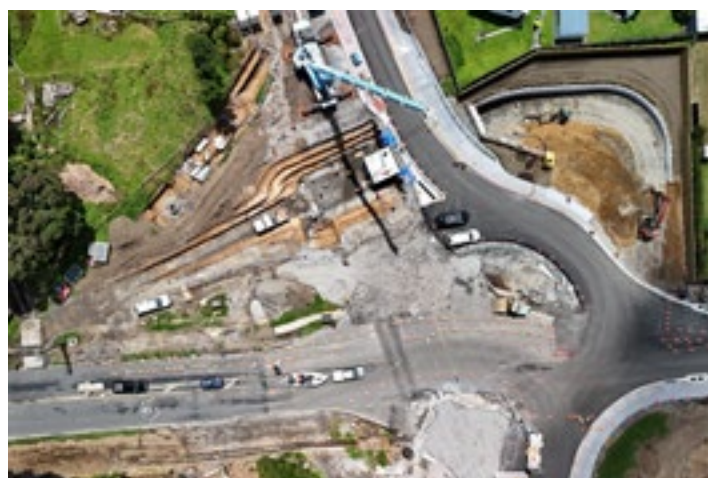
Aerial view of the underpass under construction

The construction of the pedestrian underpass was a mammoth task. Over 1500m³ of earth was removed to make way for the underpass, that's enough earth to fill almost 5,000 bathtubs, all while the highway stayed open to traffic.

The pedestrian underpass itself is made up of 19 concrete frames each weighing 15 tonnes. Because the frames are so heavy a special crane strong enough to lift each one was brought in to put them in place.

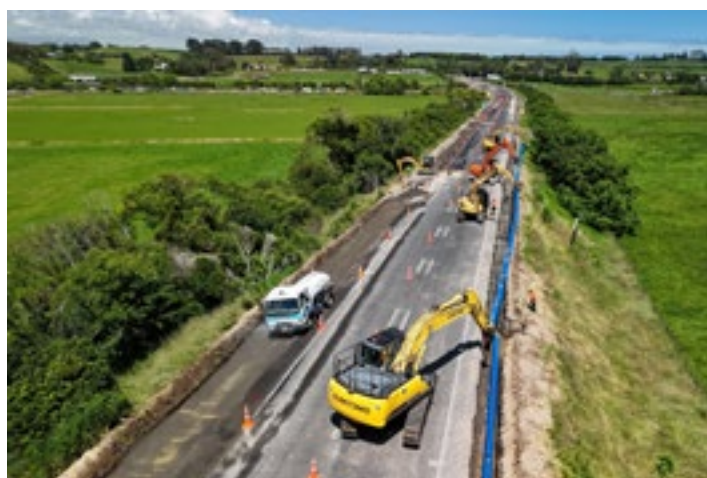
Completing work on the highway during the summer closure

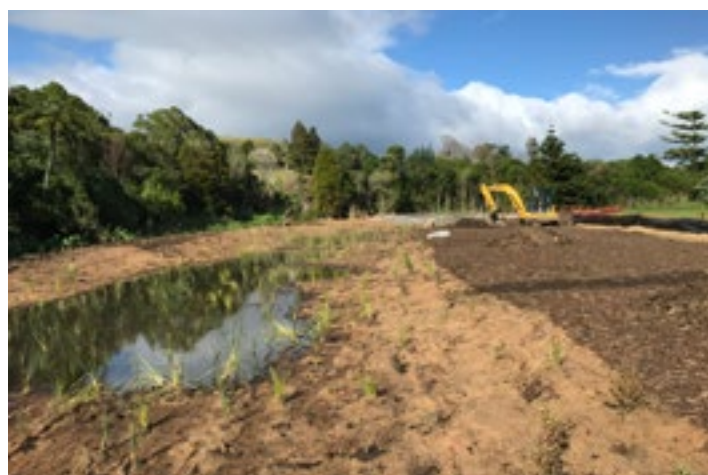
Construction underway on the stormwater wetland swale

Key to the new stormwater system is a new stormwater wetland swale that has been constructed at Manukorihi Park. The wetland swale has been planted with special plants that help remove contaminants. Once treated, the water is safely discharged into the stream in Manukorihi Park, which eventually discharges into the Waitara River (River). A stormwater outfall has also been constructed at the Waitara Awa which will safely discharge excess water in the event of heavy rain – preventing the wetland swale from flooding.

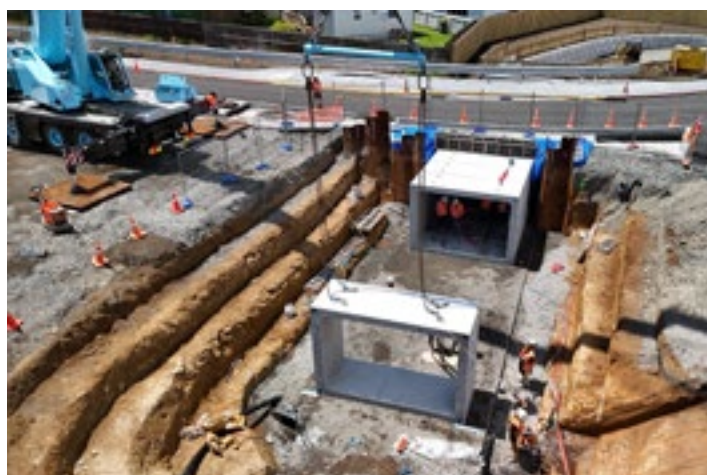
Concrete frame being installed for the underpass

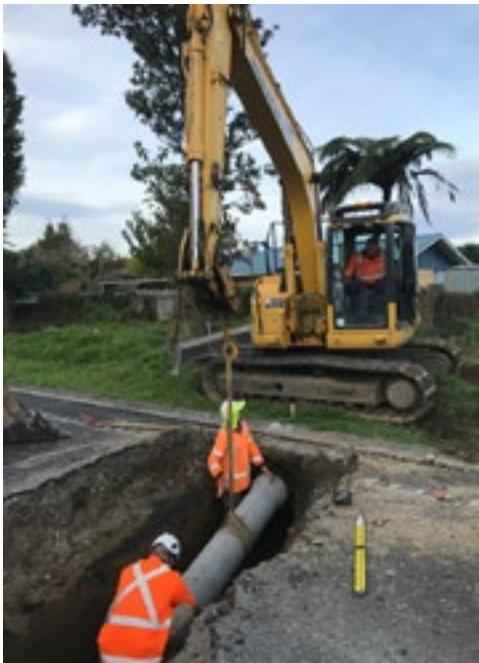
Installing a pipe to handle stormwater

Before work on the roundabout itself could begin, stormwater work took place to ensure that water would drain away quickly from the road and to prepare for future housing development. This involved digging 5 metres into the ground to install new pipes – all while navigating a network of gas, power, and internet cables and a high ground water table, which required water to be constantly pumped out of the work site.

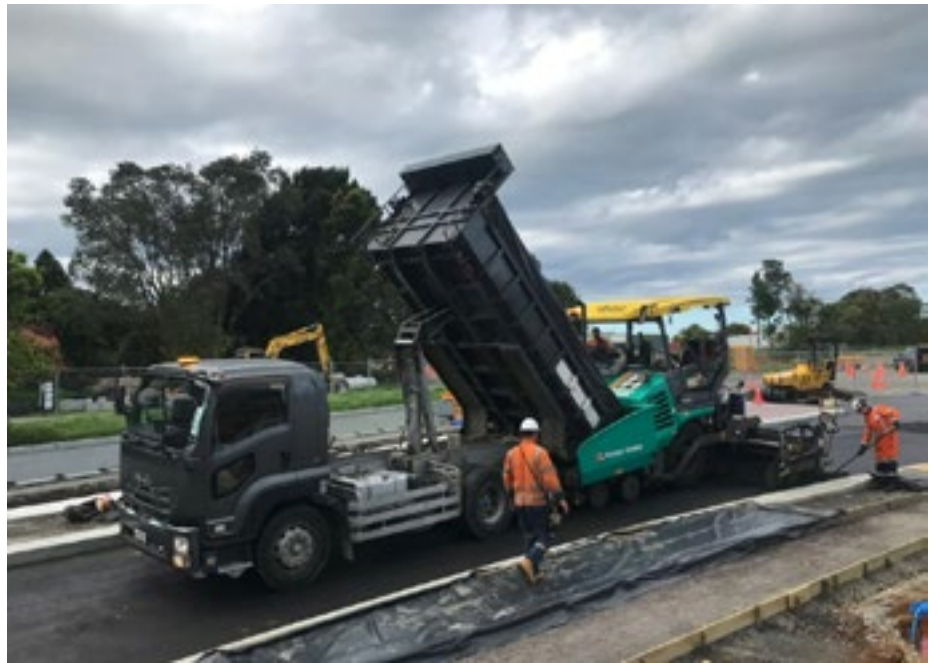
Laying asphalt on the highway

With the stormwater system complete and the underpass in place, the road could be rebuilt, and the roundabout installed. This involved widening the road in places, laying concrete foundations to ensure the road at the intersection is long lasting, laying down metal and asphalt and of course building the roundabout itself – all while allowing traffic to travel through the intersection.

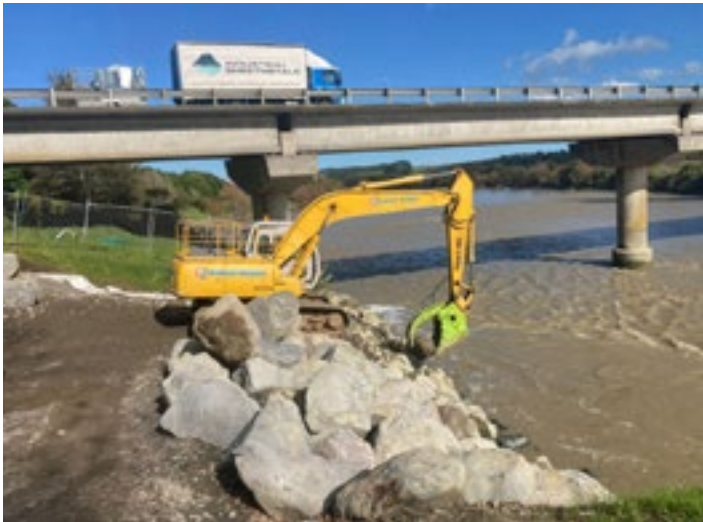
Placing rip rap for the stormwater outfall at the Waitara River

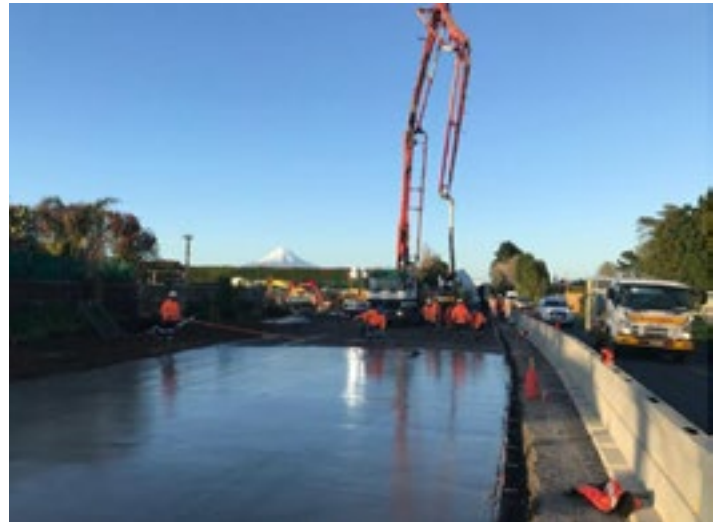
Pavement work being completed on the state highway
