**Traffic standards and guidelines  
2003/2004 survey**

**RSS 22  
Road markings**

**August 2004**

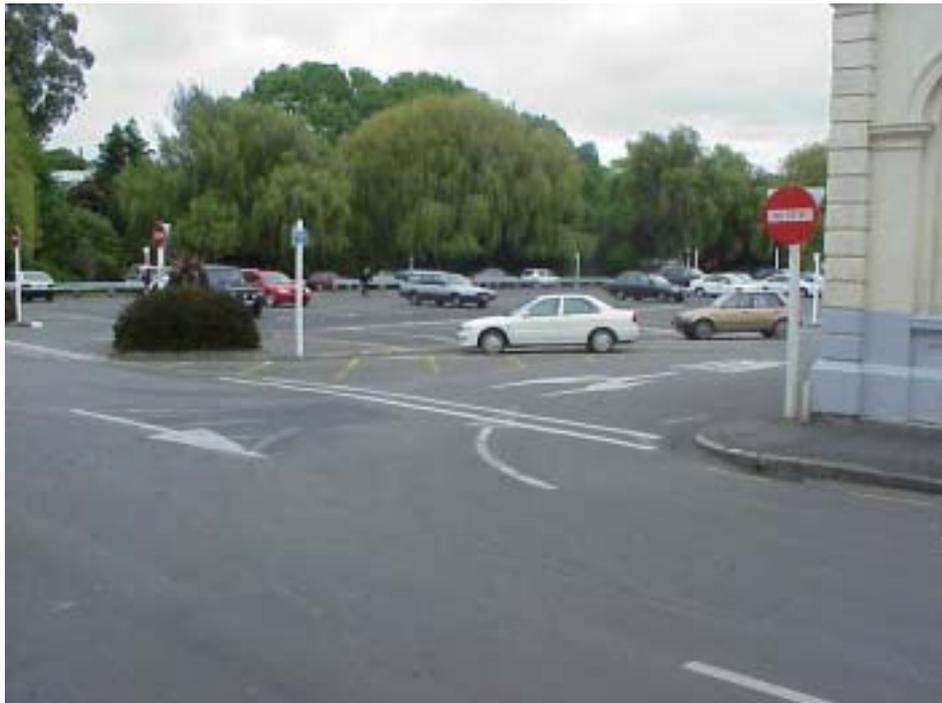
Confusing 'blacked out' right turn arrow.

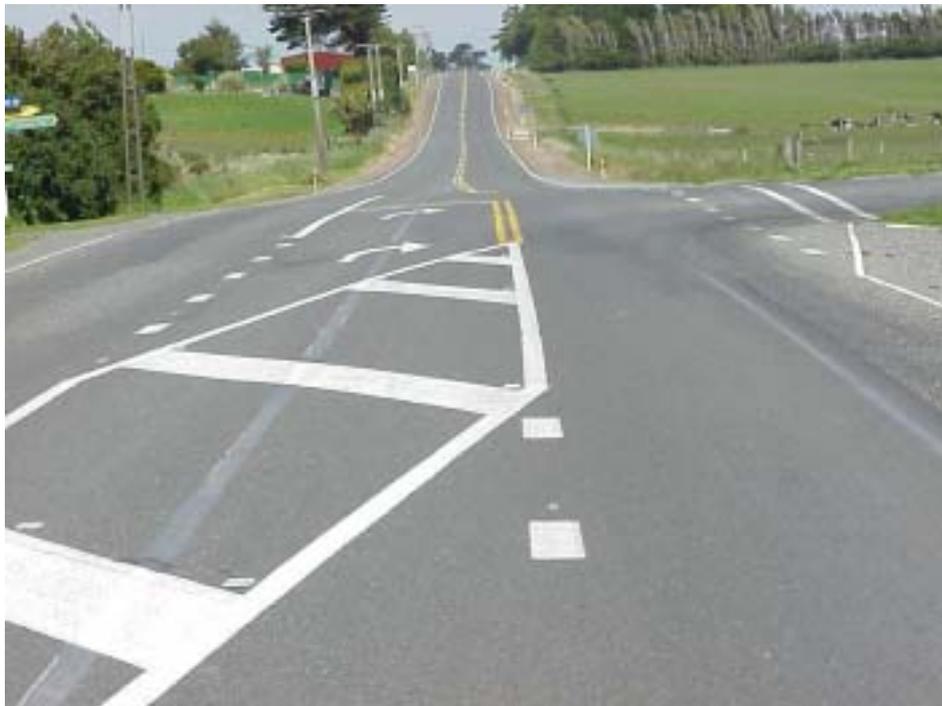
Unsafe delineation from 'blacked out' unwanted centre and edge lines. Glass bead was clearly evident on the blacked out markings. Tests showed these lines had higher reflectivity than the new white lines and would therefore be more visible at night (reflectivity readings of 111 and 64 on the blacked out lines, compared with 58 to 80 on the new white lines).

- using reflectorised markings to improve night-time visibility, especially for no passing lines and centre lines
- completing reseals to remove unwanted markings if removal by blacking out or abrasion blasting could result in unsafe delineation
